TIRPITZ

An account of the various attacks
carried out by the British Armed
Forces and their effect upon the
German Battleship

Volume 1
REPORT AND APPENDICES

ADMIRALTY,
31st March, 1949

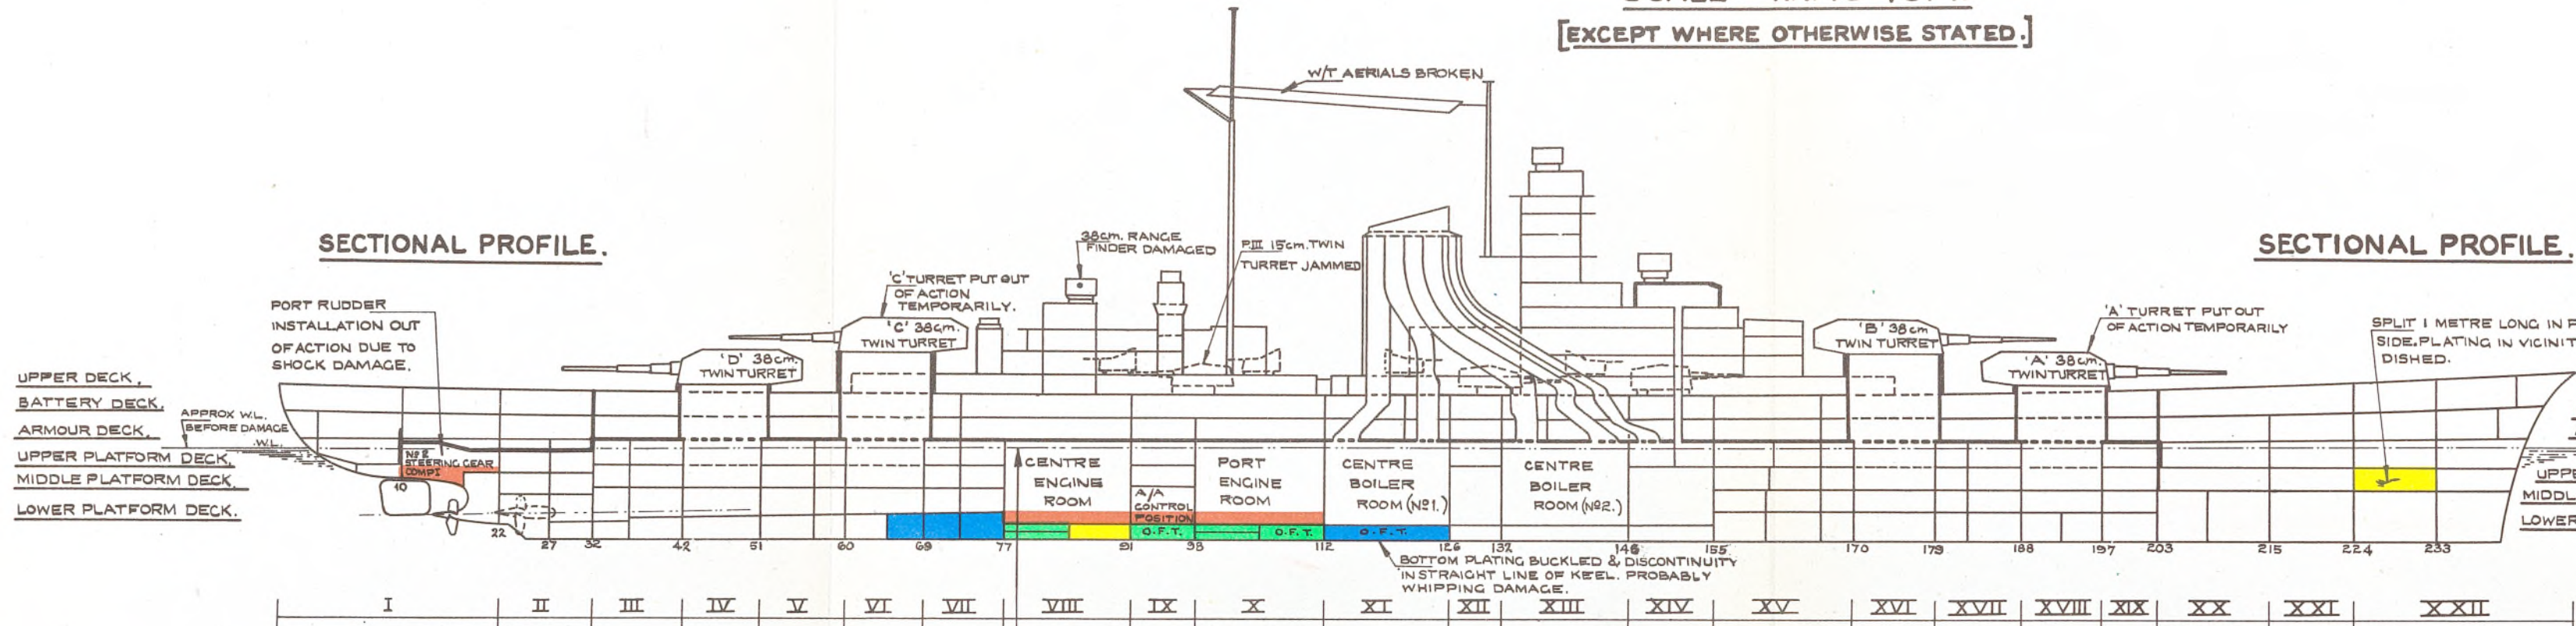
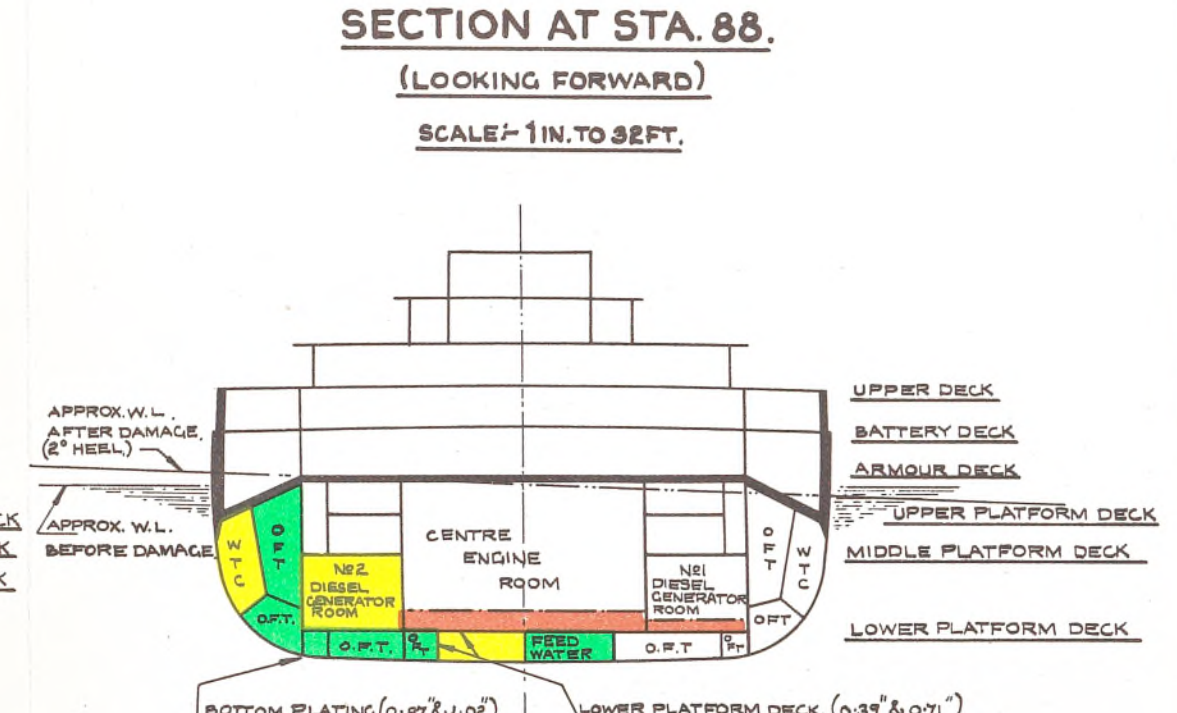
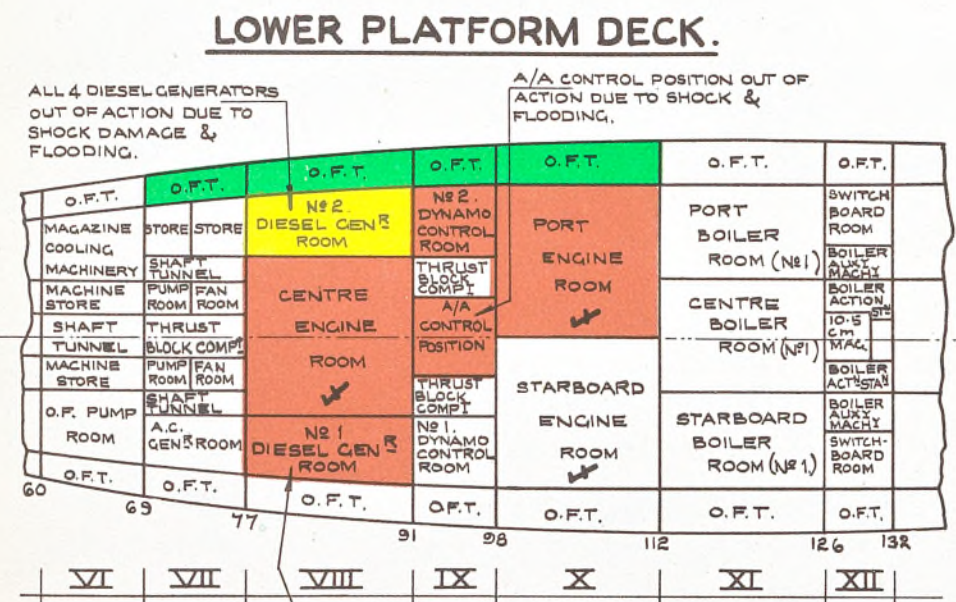
5.1 The bottom plating in way of the engine rooms was split and dished, the longest split being about 8 metres (approximately 26 feet). The inner bottom and longitudinals in the damaged area were forced upwards and buckled and all the pipes, including condenser inlets and outlets, were subjected to shock.

3 OUT OF 4 DIESEL GENERATORS OUT OF ACTION DUE TO SHOCK DAMAGE

ALL THREE MAIN ENGINES PUT OUT OF ACTION DUE TO SHOCK DAMAGE. PORT ENGINE MORE SERIOUSLY DAMAGED THAN THE OTHERS.

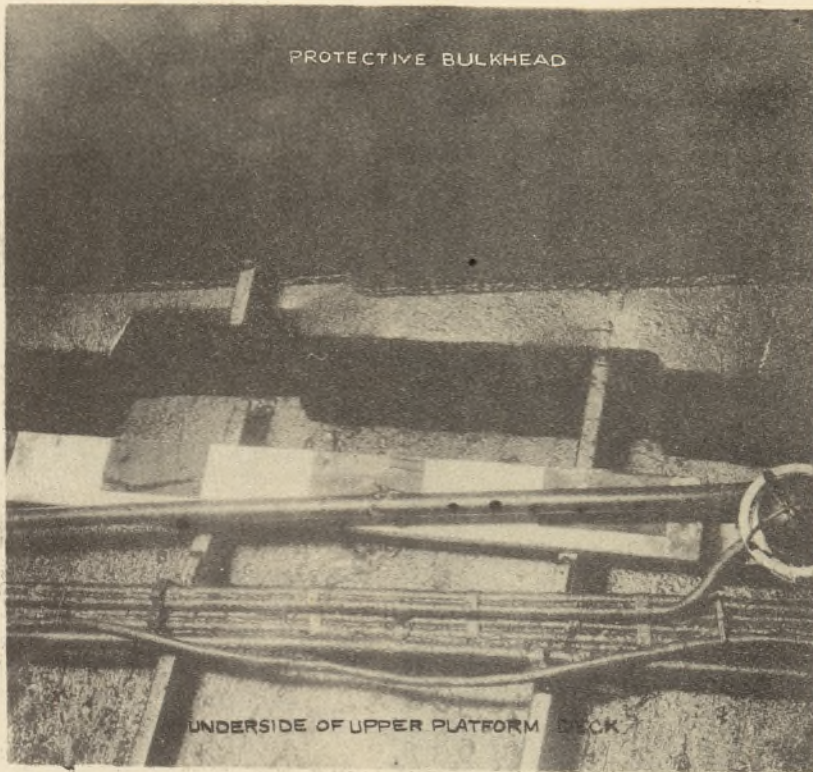
Damage due to internal explosion.

Crack in deck.
(See ① fig.B.4.2)

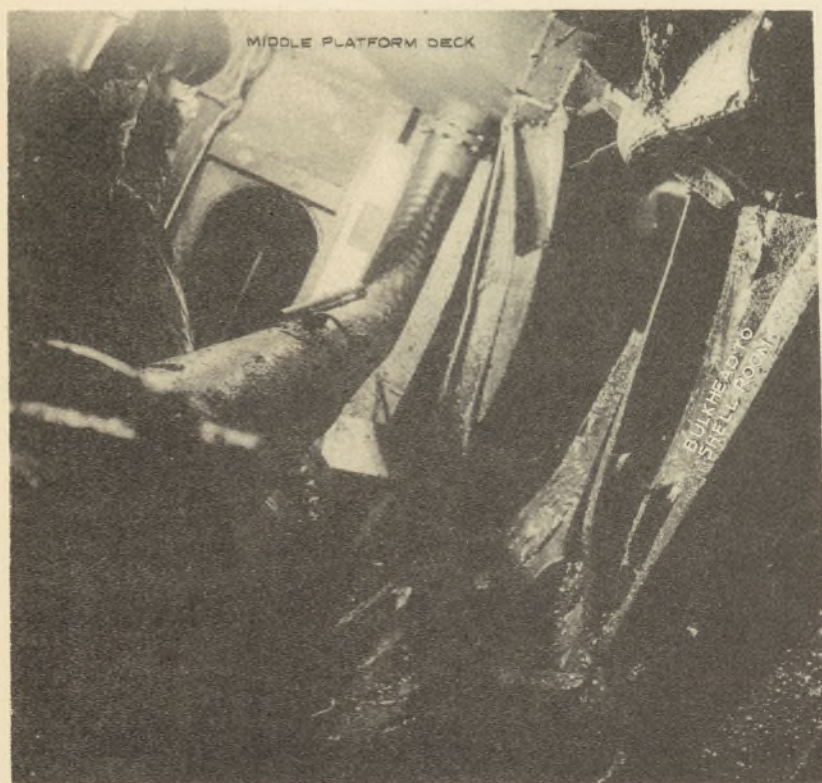
Port cable passage on Middle Platform deck (Section III).

Shell room bulkhead fractured along line of vertical welding and blown in-board.

(See ③ fig.B.4.2)

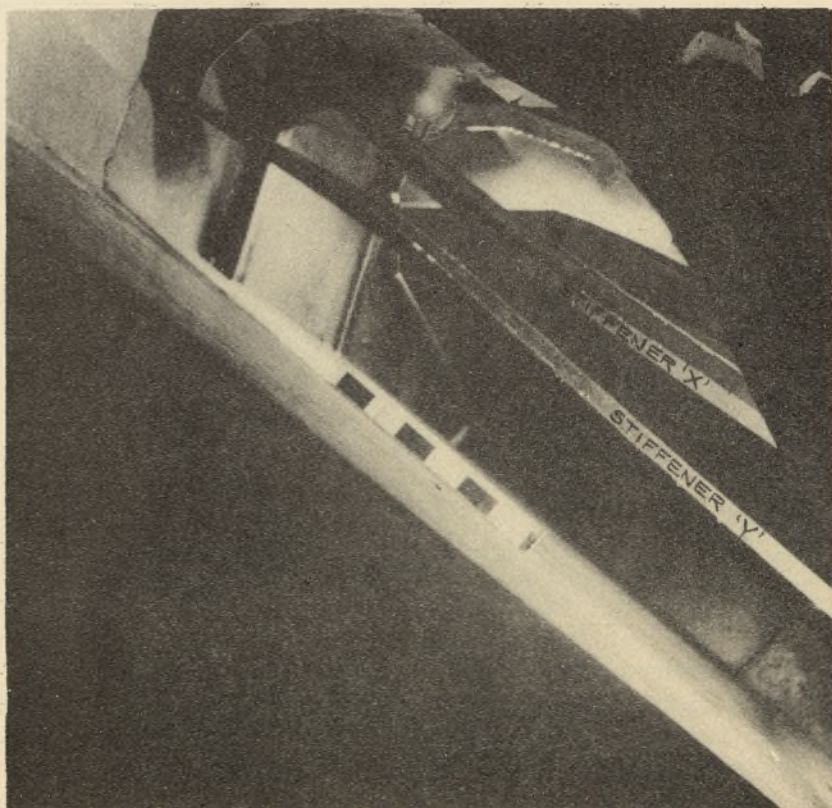
Transverse bulkhead blown away
from stiffeners, leaving stiffeners
in original position.

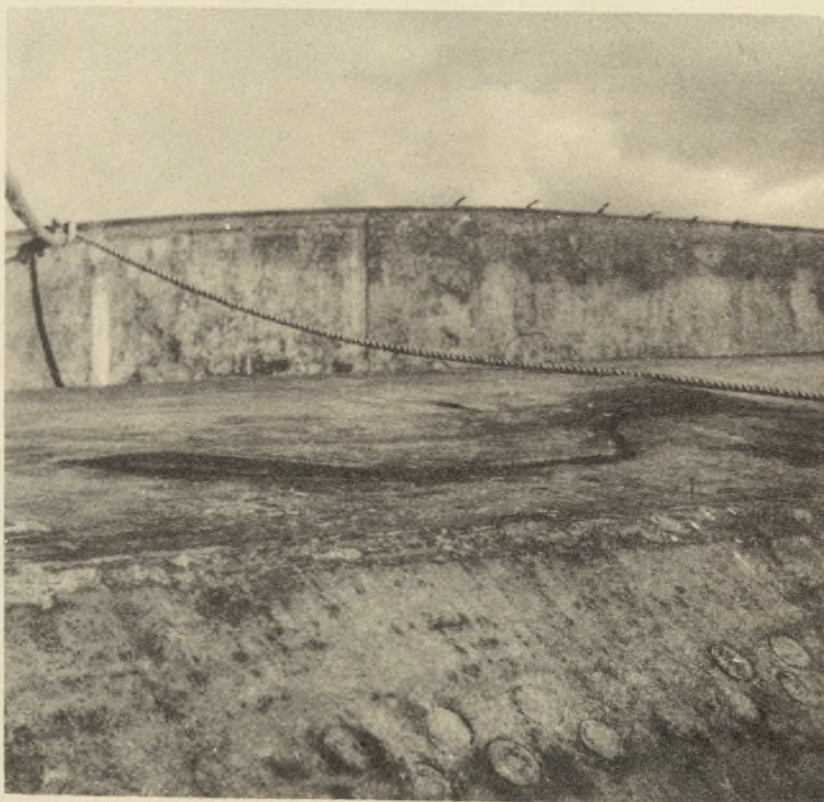
Damage to outer bottom plating
due to 1,600 lb. A.P. bomb (Fleet
Air Arm attack on 3rd April 1944;
-Hit No. XII).

Crack made good by driving in
liners, and by under water
welding.

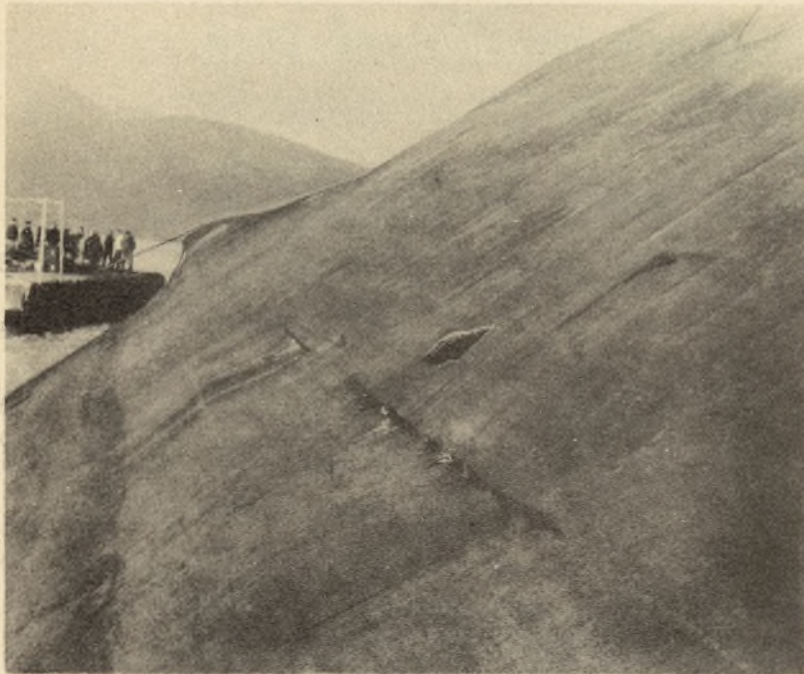
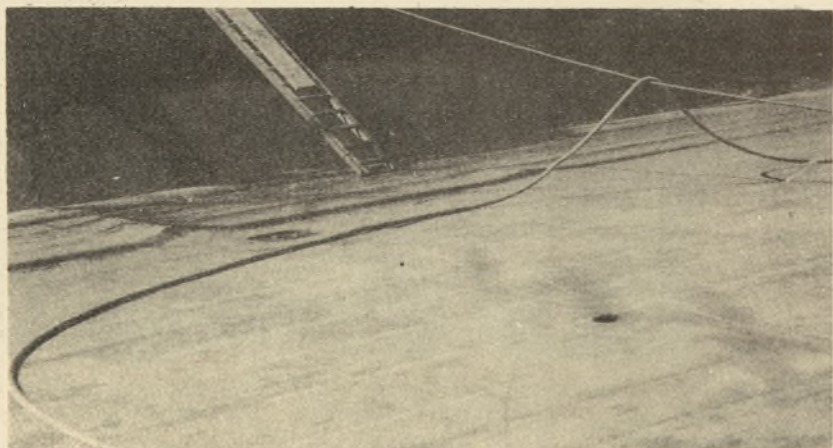
Views of damage probably due to
the X-Craft attack (22nd Sept. 1943).

Crack in weld
and dishing in
flat keel plating.

Buckling of
flat bottom
plating due
to whipping.

Wedges driven
from inboard.

Hole cut to
examine damage
from inboard.

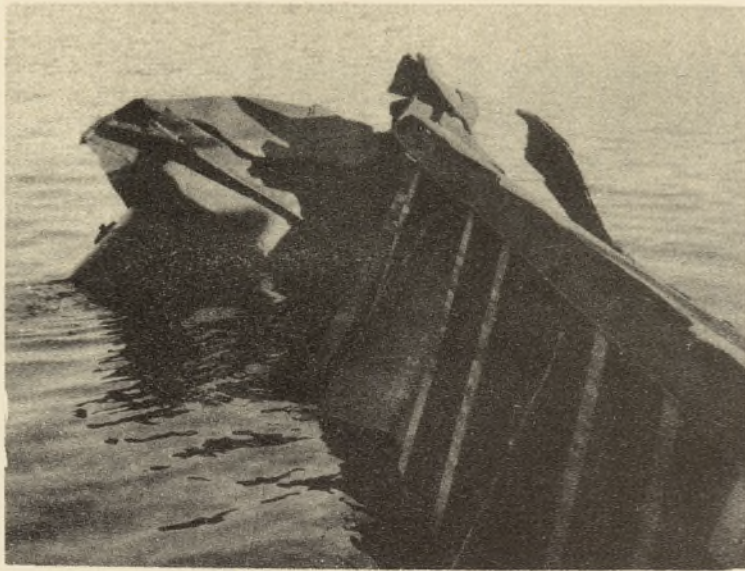
Damage at fore end due to near
miss bomb (15th Sept. 1944).

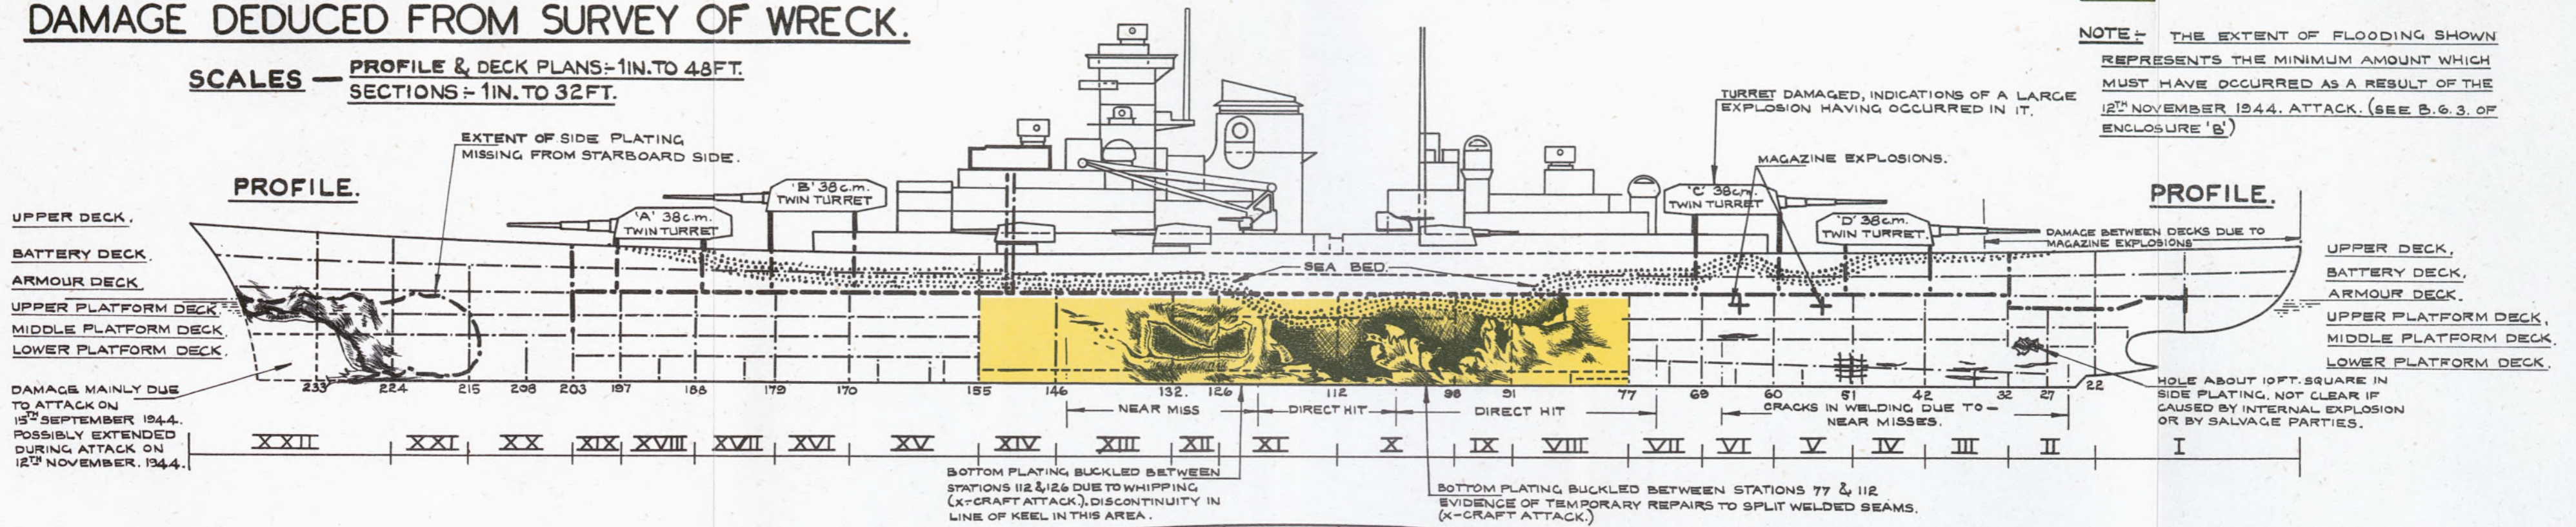
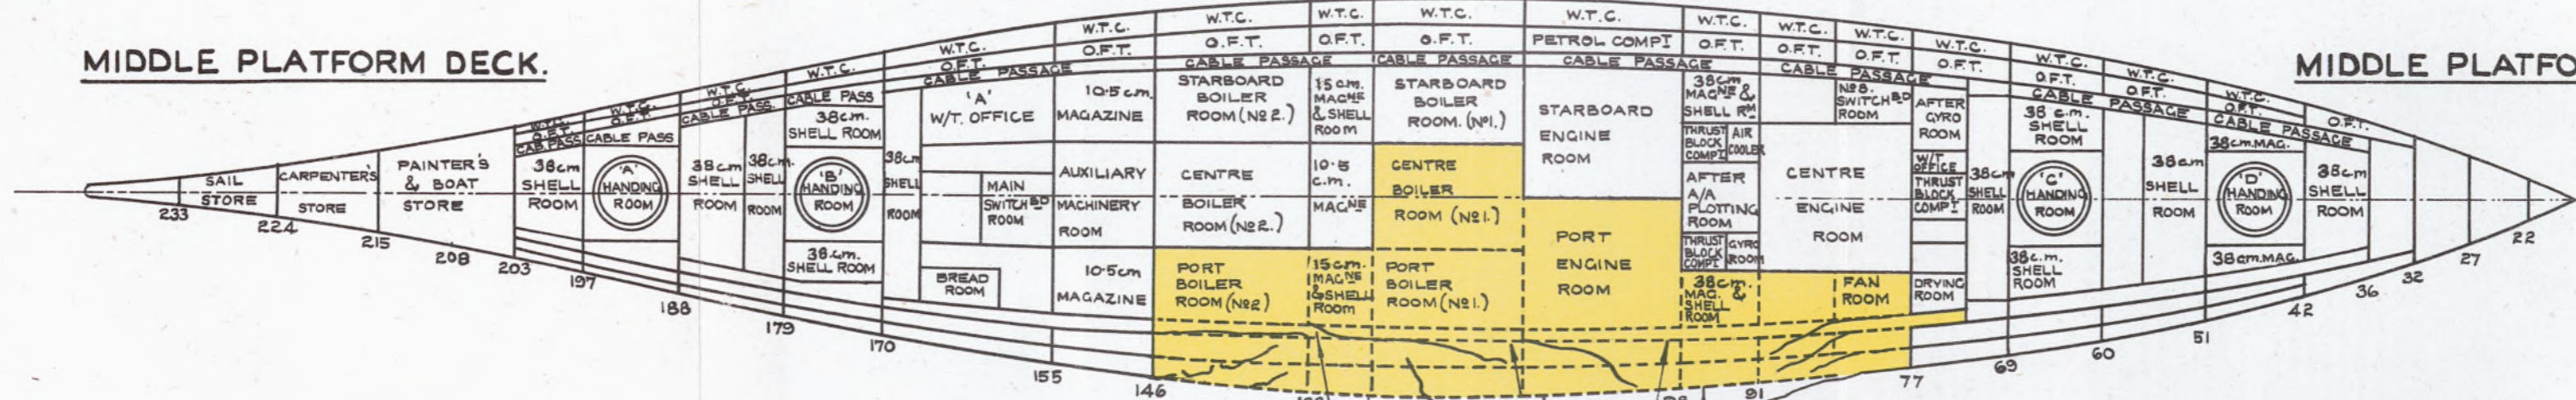
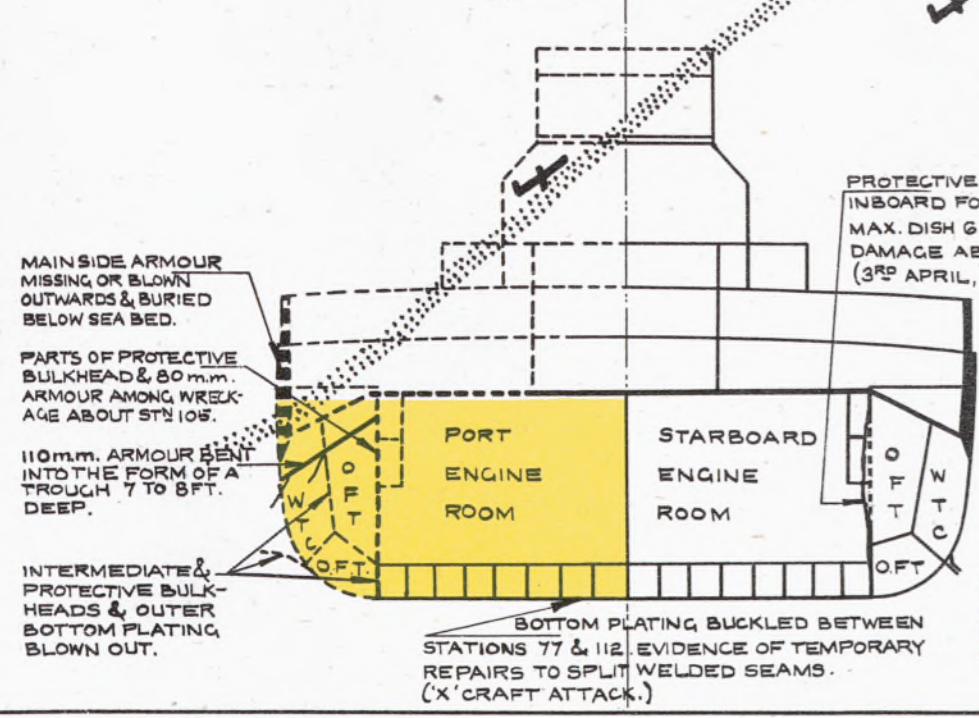
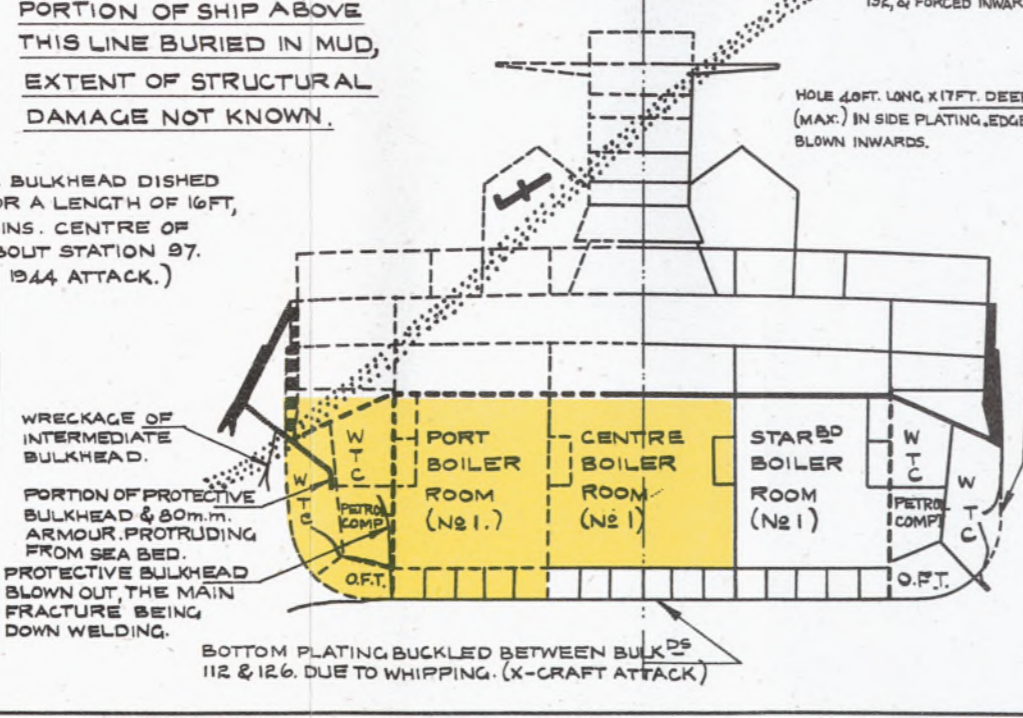
FIGURE B.5.

NOTE — THE EXTENT OF FLOODING SHOWN REPRESENTS THE MINIMUM AMOUNT WHICH MUST HAVE OCCURRED AS A RESULT OF THE 12TH NOVEMBER 1944. ATTACK. (SEE B.6.3. OF ENCLOSURE 'B')
