TIRPITZ

An account of the various attacks
carried out by the British Armed
Forces and their effect upon the
German Battleship

Volume 2

EVIDENCE FOR DETAILED
ACCOUNTS OF DAMAGE

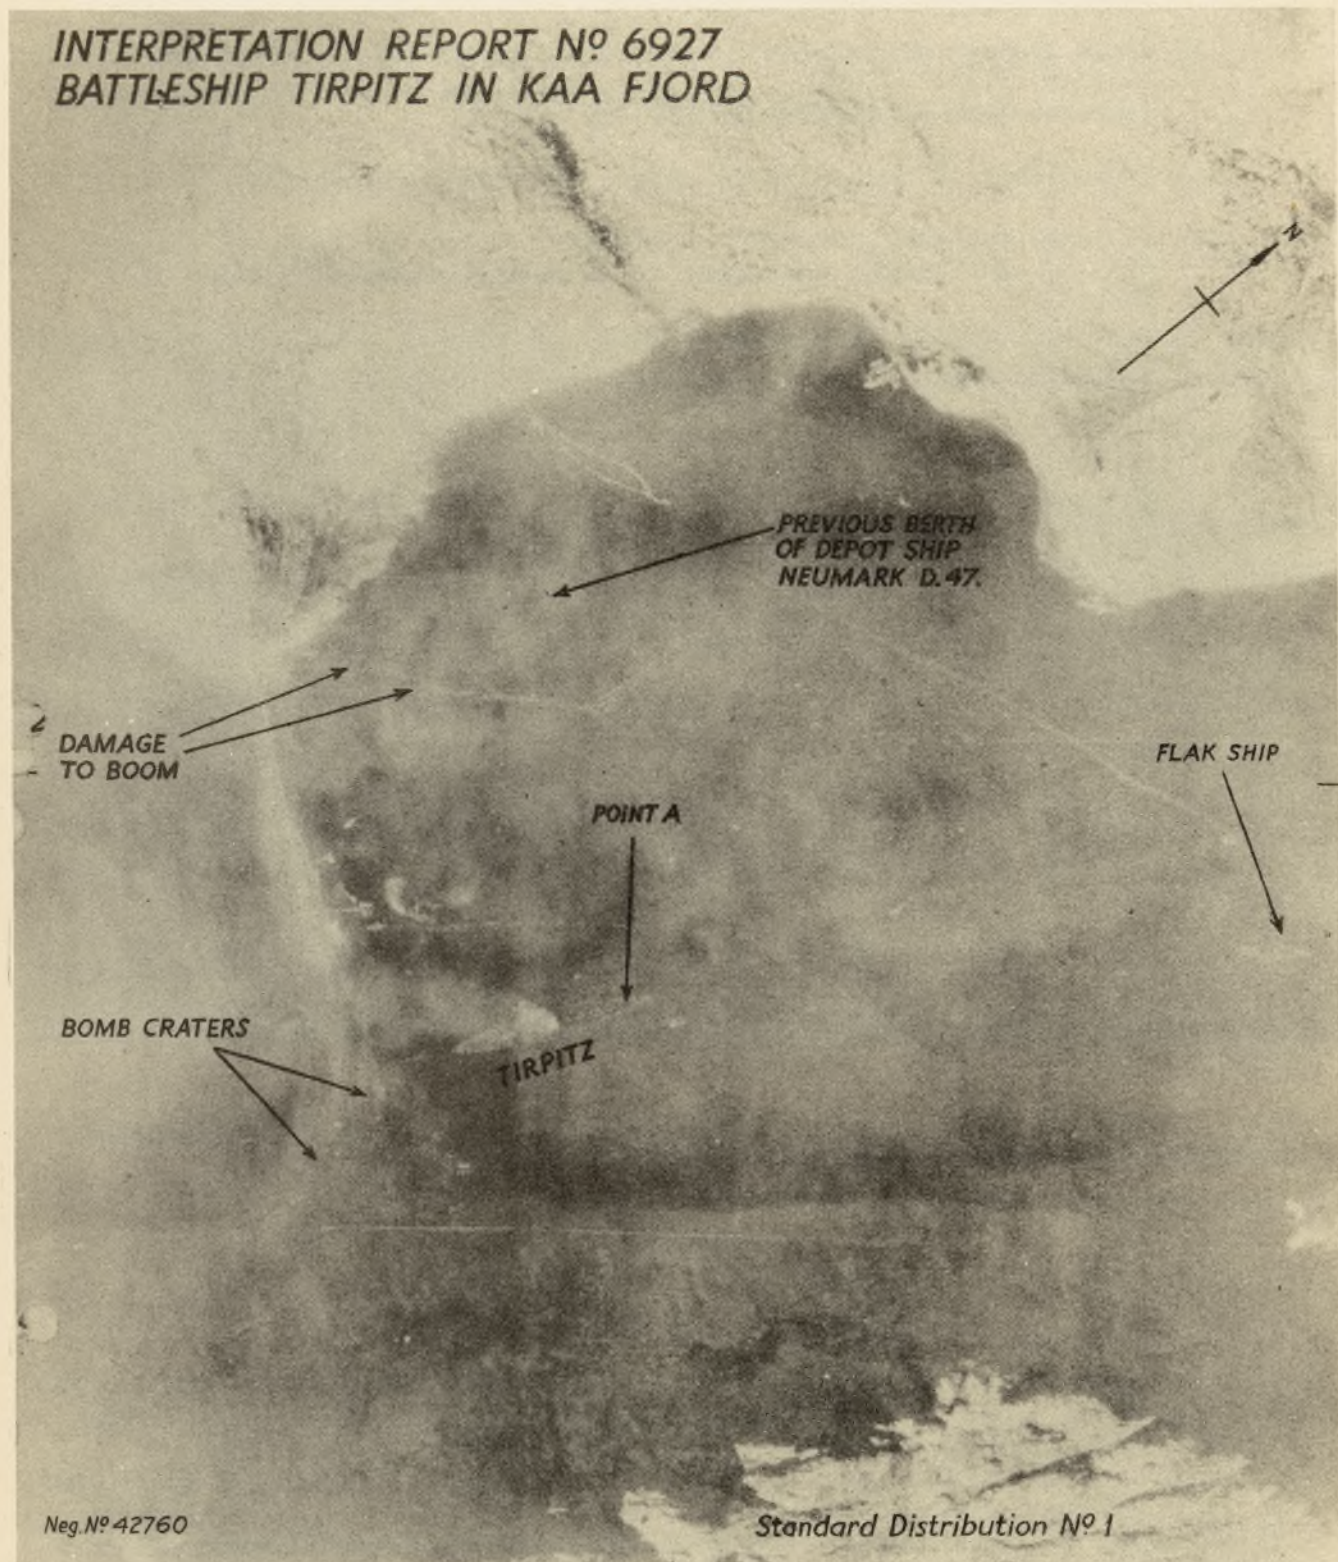
Neg. Nº 42760

(b) An accurate statement on damage is not possible and shadow almost entirely obscures details of the port side. It does seem, however,

INTERPRETATION REPORT Nº 6927
BATTLESHIP TIRPITZ IN KAA FJORD

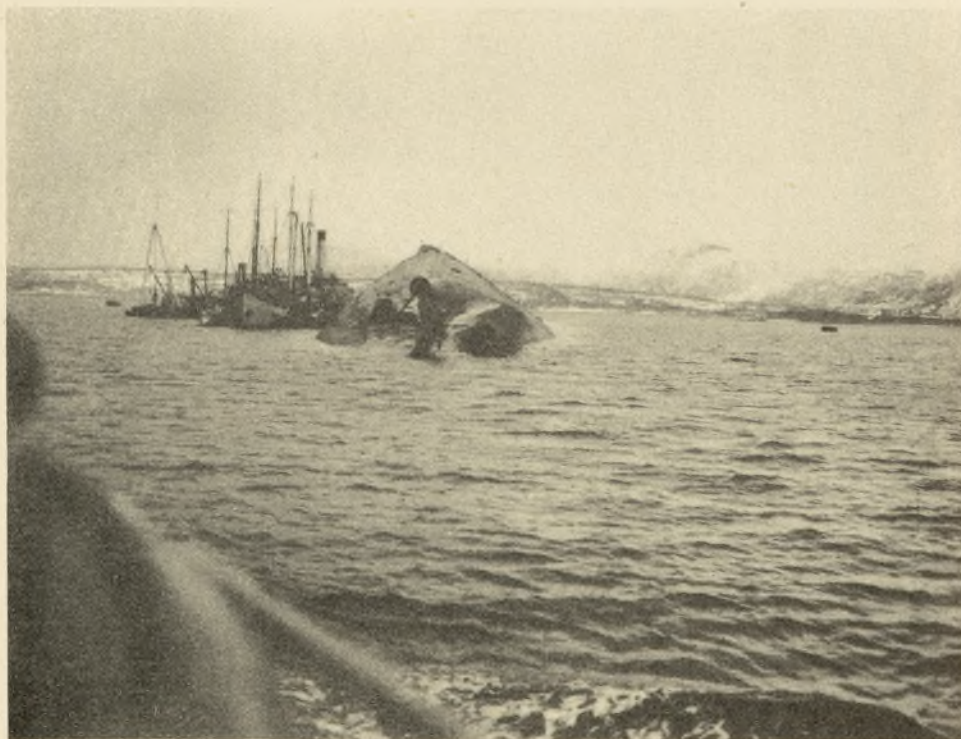
STERN VIEW SHOWING DAMAGED RUDDER AND SCREWS REMOVED

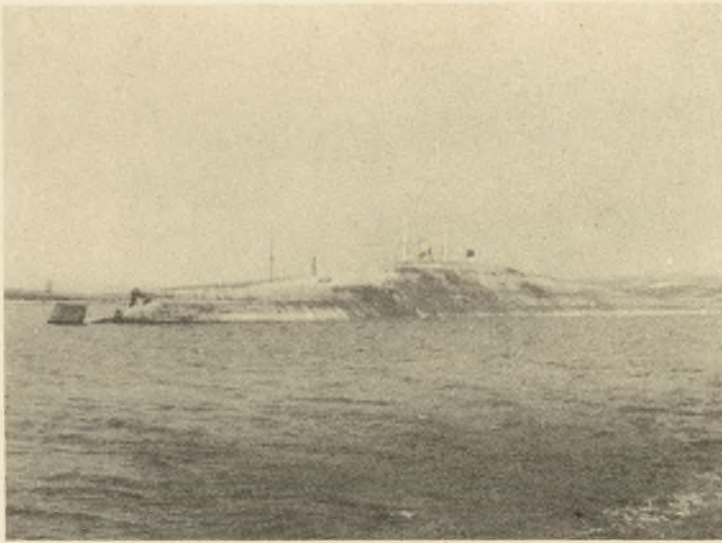
GENERAL VIEW FROM WATER SHOWING DAMAGED RUDDER

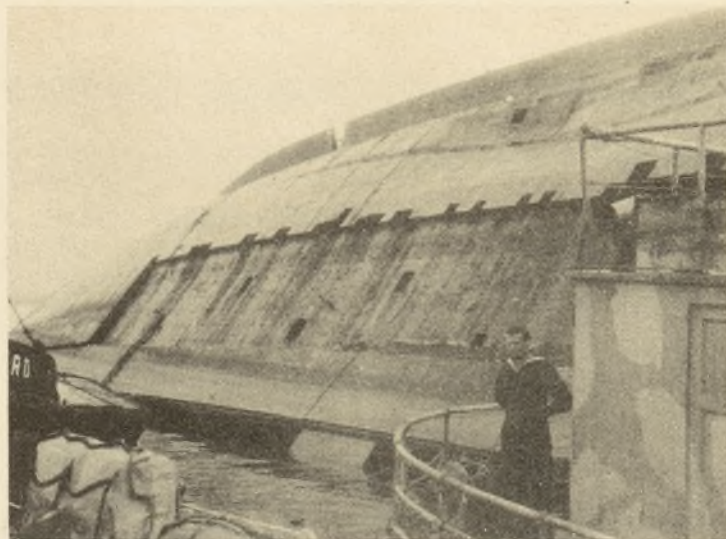
←
Dent from
near miss
12,000 lb. bomb

STARBOARD SIDE SHOWING ARMOUR REMOVED

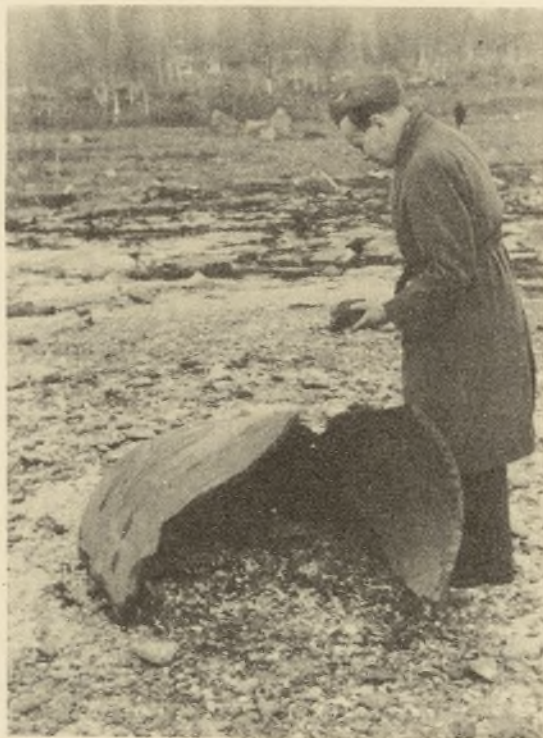
FRACTURED 12,000 lb. BOMB BODY
ON FORESHORE

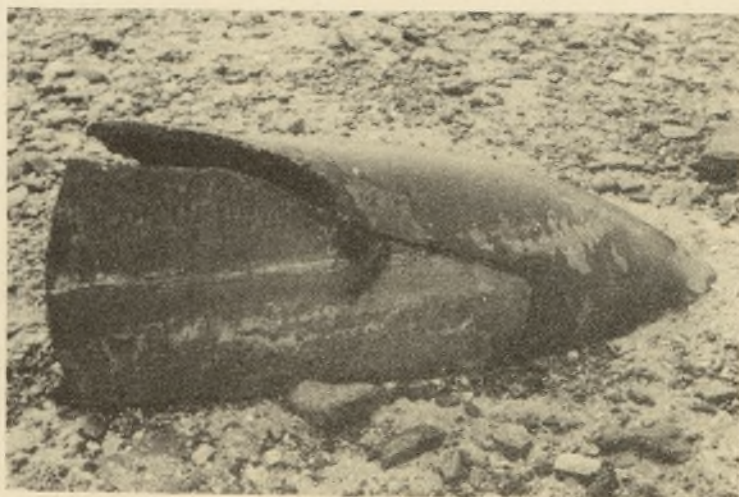
FRACTURED 12,000 lb. BOMB BODY
ON FORESHORE
