THE DISAPPEARANCE OF THE “LATHAM”

REPORT BY A SPECIAL EXPERT GROUP

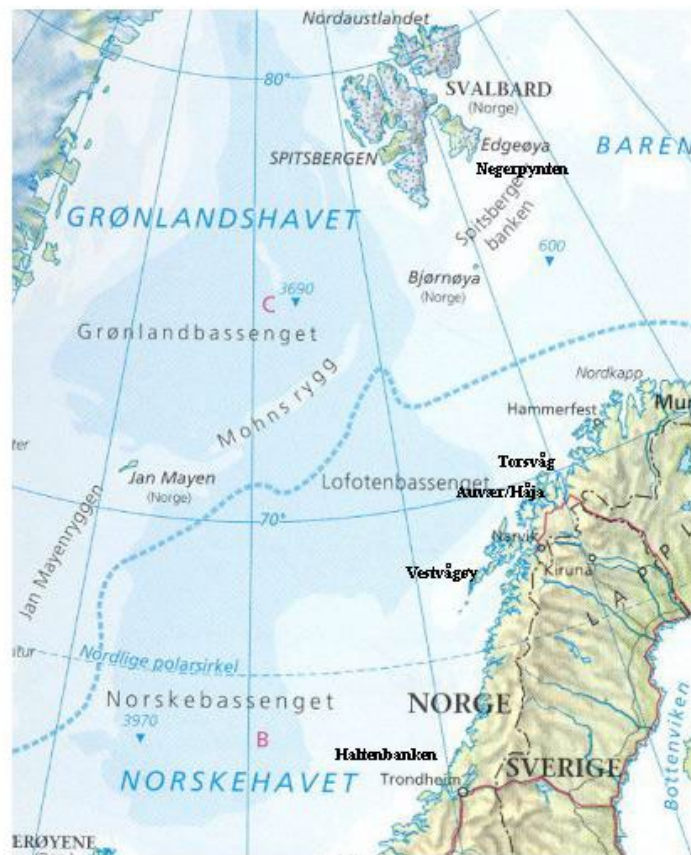
- Pontoon found at Torsvåg on 31 August 1928.
It was later ascertained that this was the left wing pontoon of the “Latham 47.” In 1928 it was concluded that the pontoon had been torn from the wing, probably as a result of a hefty collision with the sea.
- Fuel tank found on the Haltenbanken, 13 October 1928.
It was ascertained that this was the Latham’s forward internal fuel tank. Subsequent modification of the tank might indicate that they had attempted to use it as a float, perhaps as a substitute for the pontoon that had been torn off.
- Sheet of plywood found on Edgeøya.
One of the many encouraging contacts made by the working group after the open hearing in Tromsø on September 30 on the disappearance of the Latham, came when they were approached by a former hunter in Svalbard, Per Johnson.
