TIRPITZ

An account of the various attacks
carried out by the British Armed
Forces and their effect upon the
German Battleship

Volume 1
REPORT AND APPENDICES

ADMIRALTY,
31st March, 1949

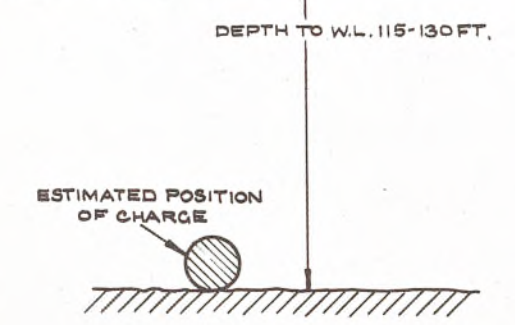
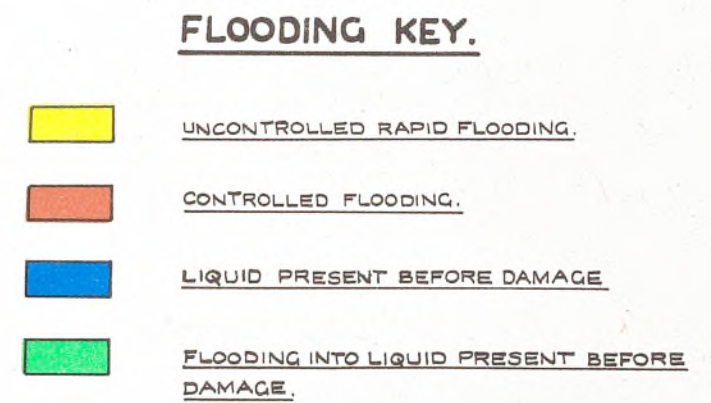
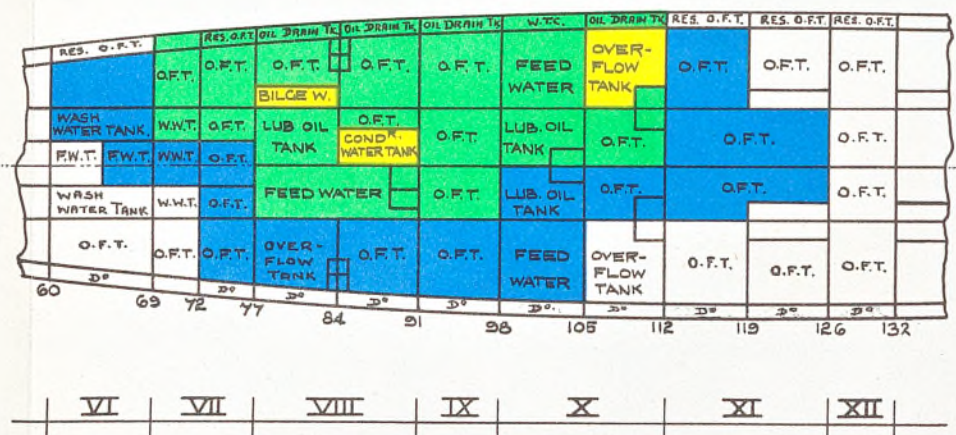
X-CRAFT ATTACK-22ND SEPT. 1943

3 OUT OF 4 DIESEL GENERATORS OUT OF ACTION DUE TO SHOCK DAMAGE

ALL THREE MAIN ENGINES PUT OUT OF ACTION DUE TO SHOCK DAMAGE. PORT ENGINE MORE SERIOUSLY DAMAGED THAN THE OTHERS.

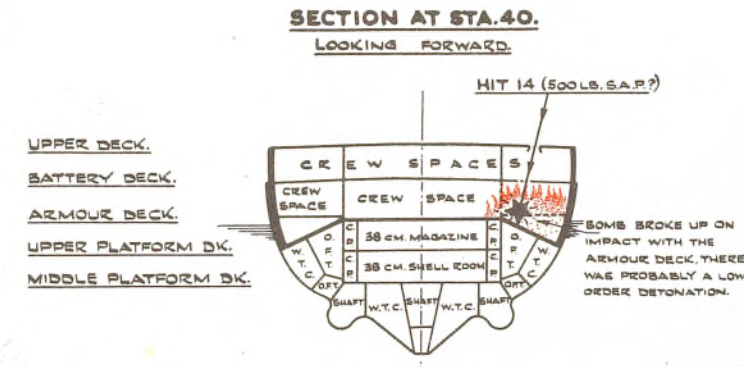
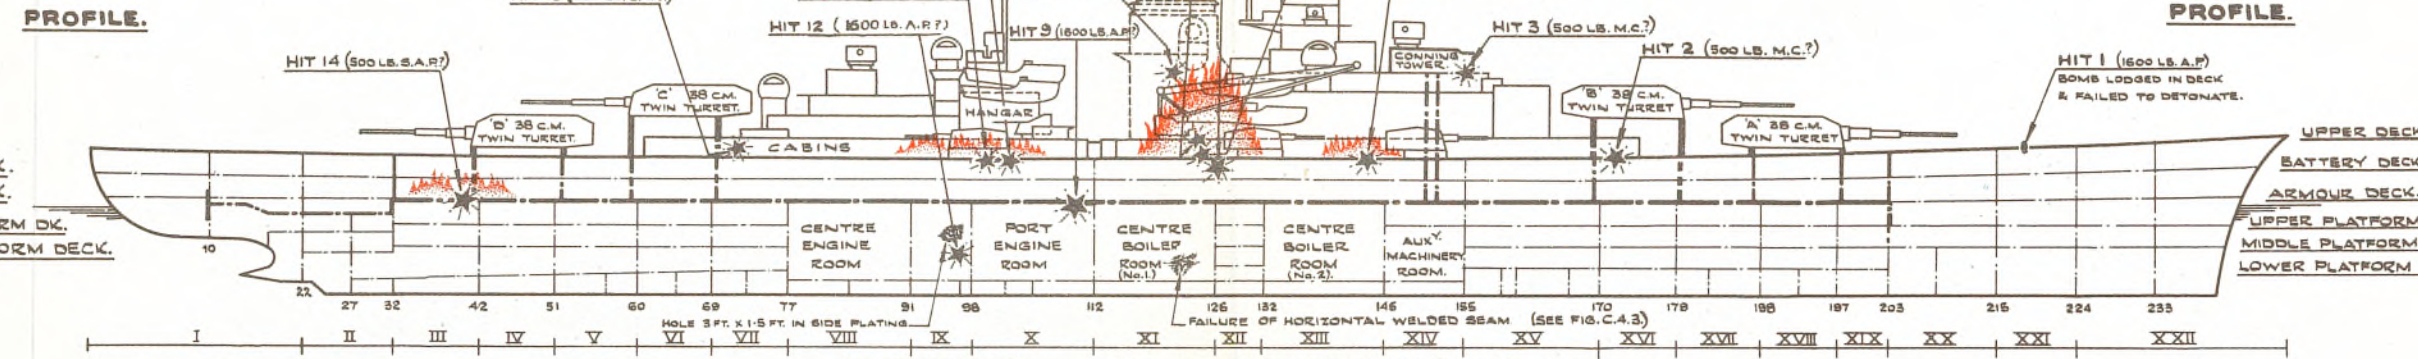
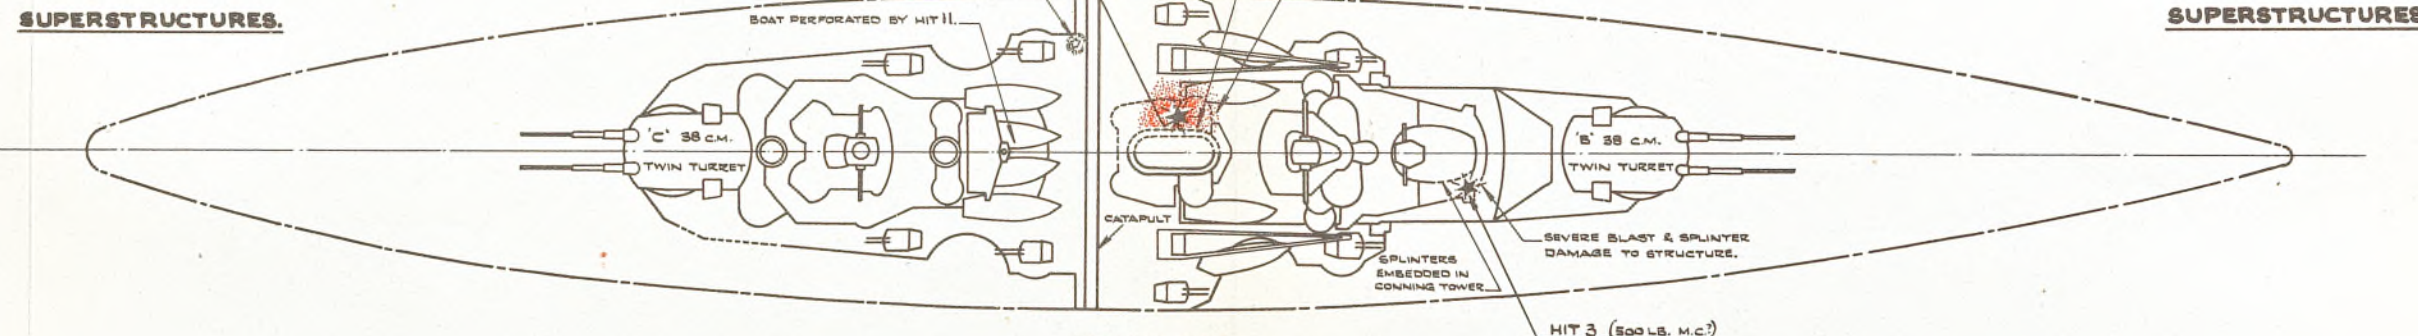
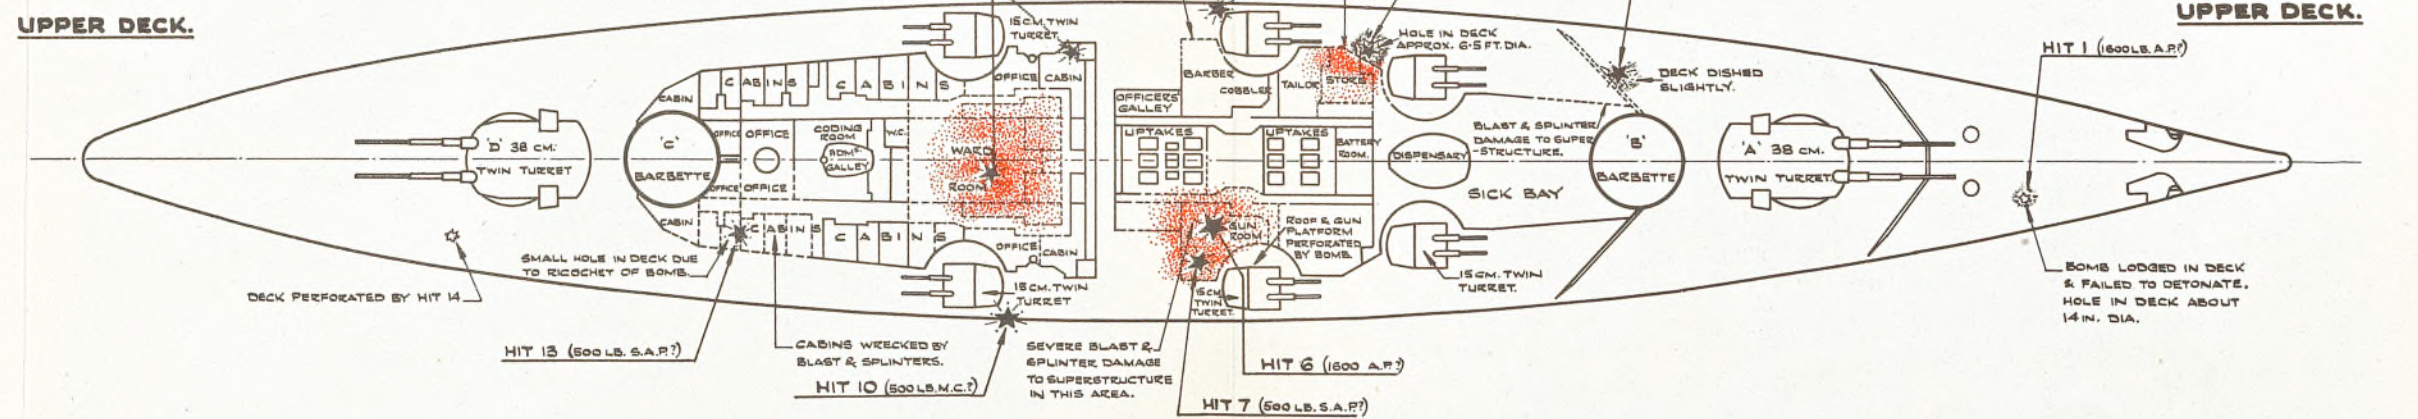
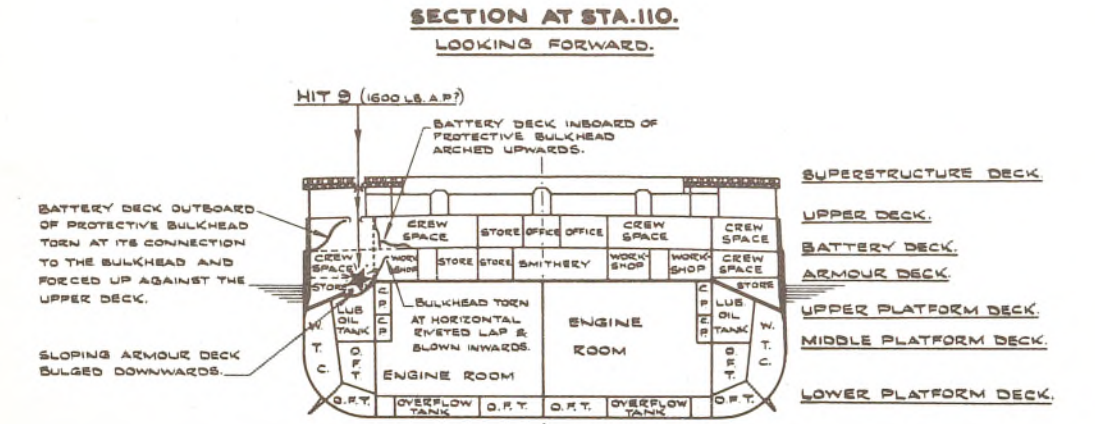
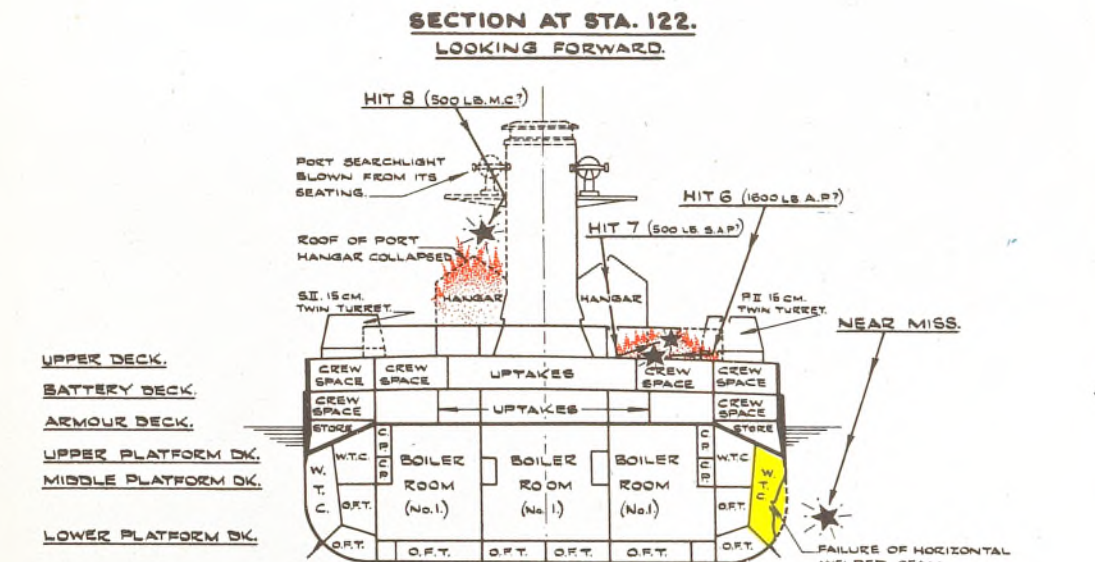
FIGURE A.2.

- UNCONTROLLED RAPID FLOODING.
- FLOODING INTO LIQUID PRESENT BEFORE DAMAGE.
- FIRE.

A.2. - DAMAGE SUSTAINED AS A RESULT OF F.A.A. ATTACK ON
3rd APRIL, 1944. (Cont'd)

3.16 Near Misses There were probably four near misses, all off the starboard side. One, probably 500 lb. M.C. or 600 lb. A/S, detonated close to the ship's side abreast the funnel and caused a hole in the side plating (0.5 and 0.8 inch) about 7 feet long by 3 feet deep, and another abreast the outer shaft bracket caused splits and dishing in the adjacent bottom plating.

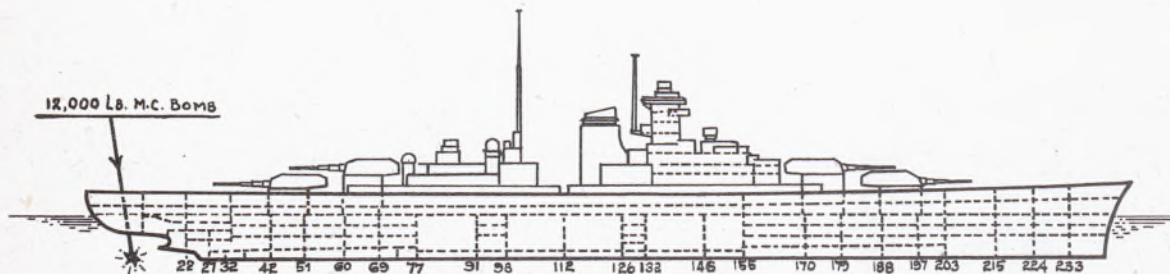
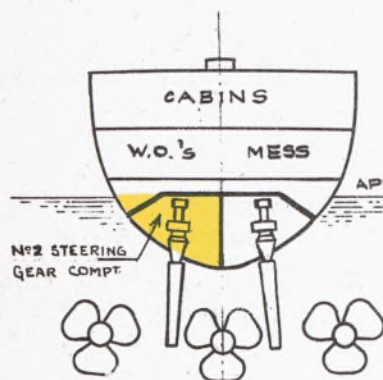
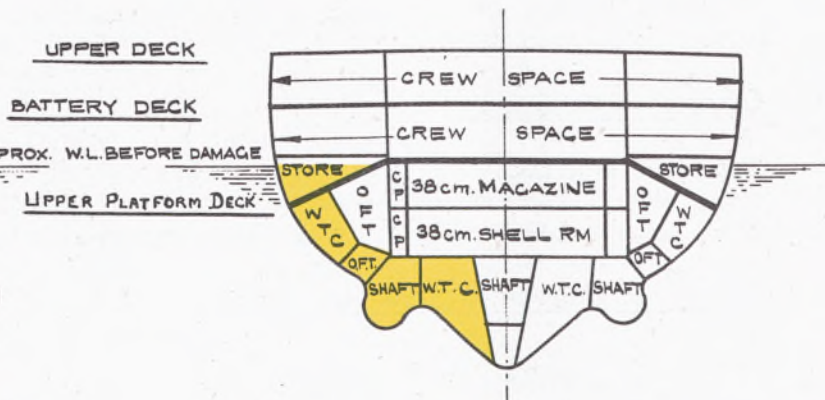
ADMIRALTY.
D.N.C. DEPT.
NG/A58
N.H.
FEBRUARY 1948

ESTIMATED POSITION OF
DETONATION OF 12,000LB.M.C.
BOMB.

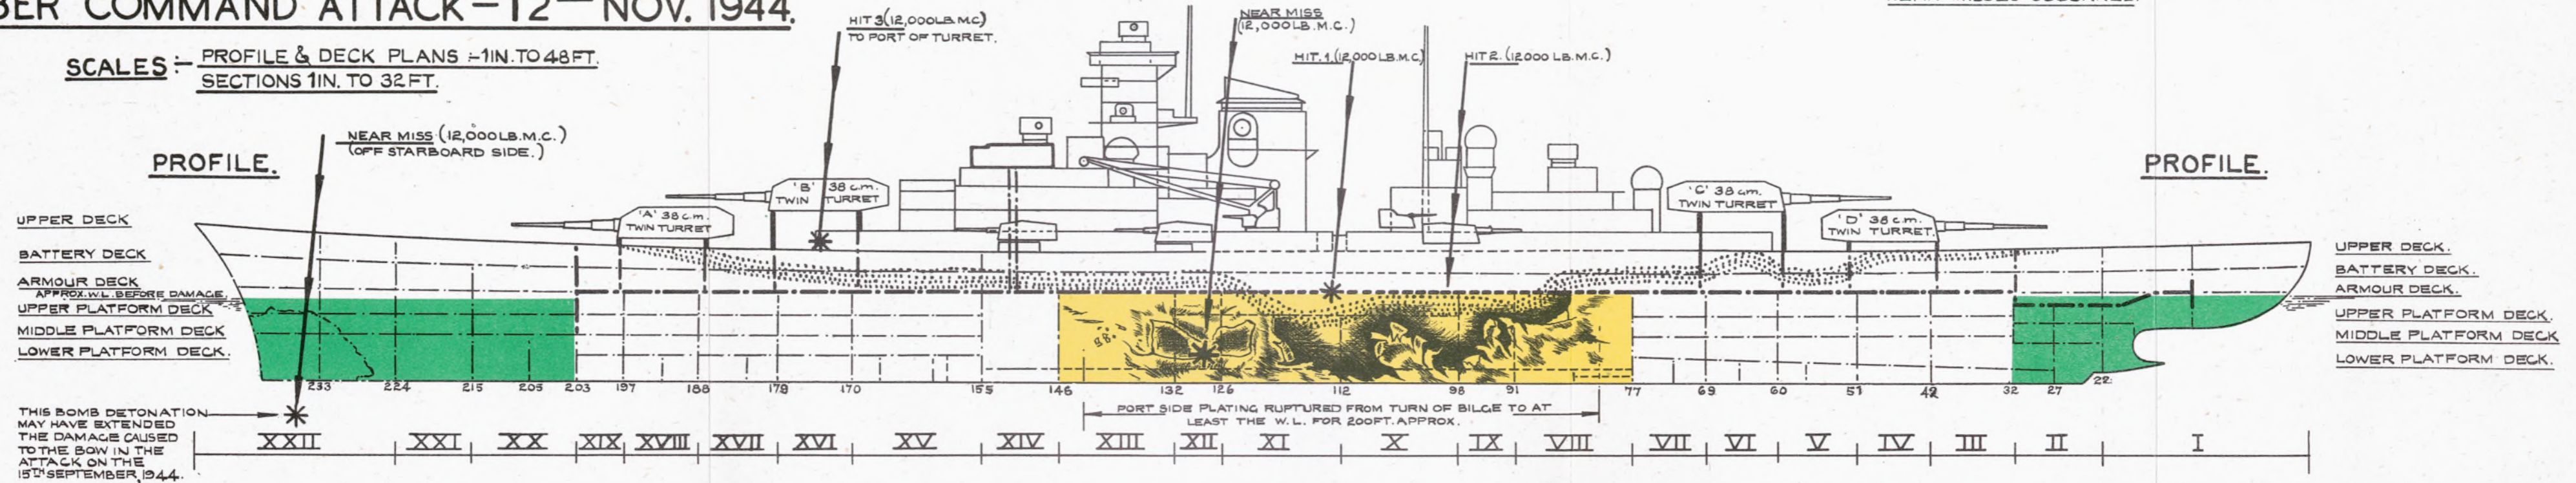
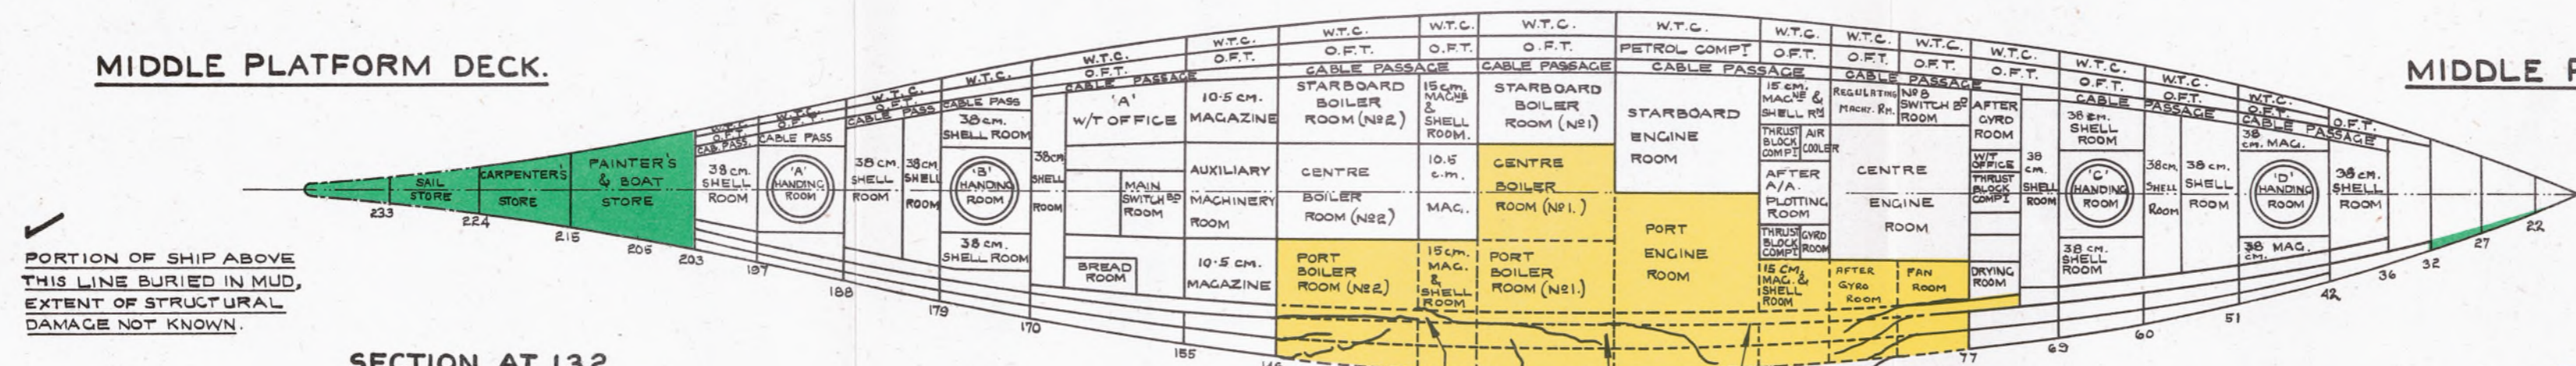
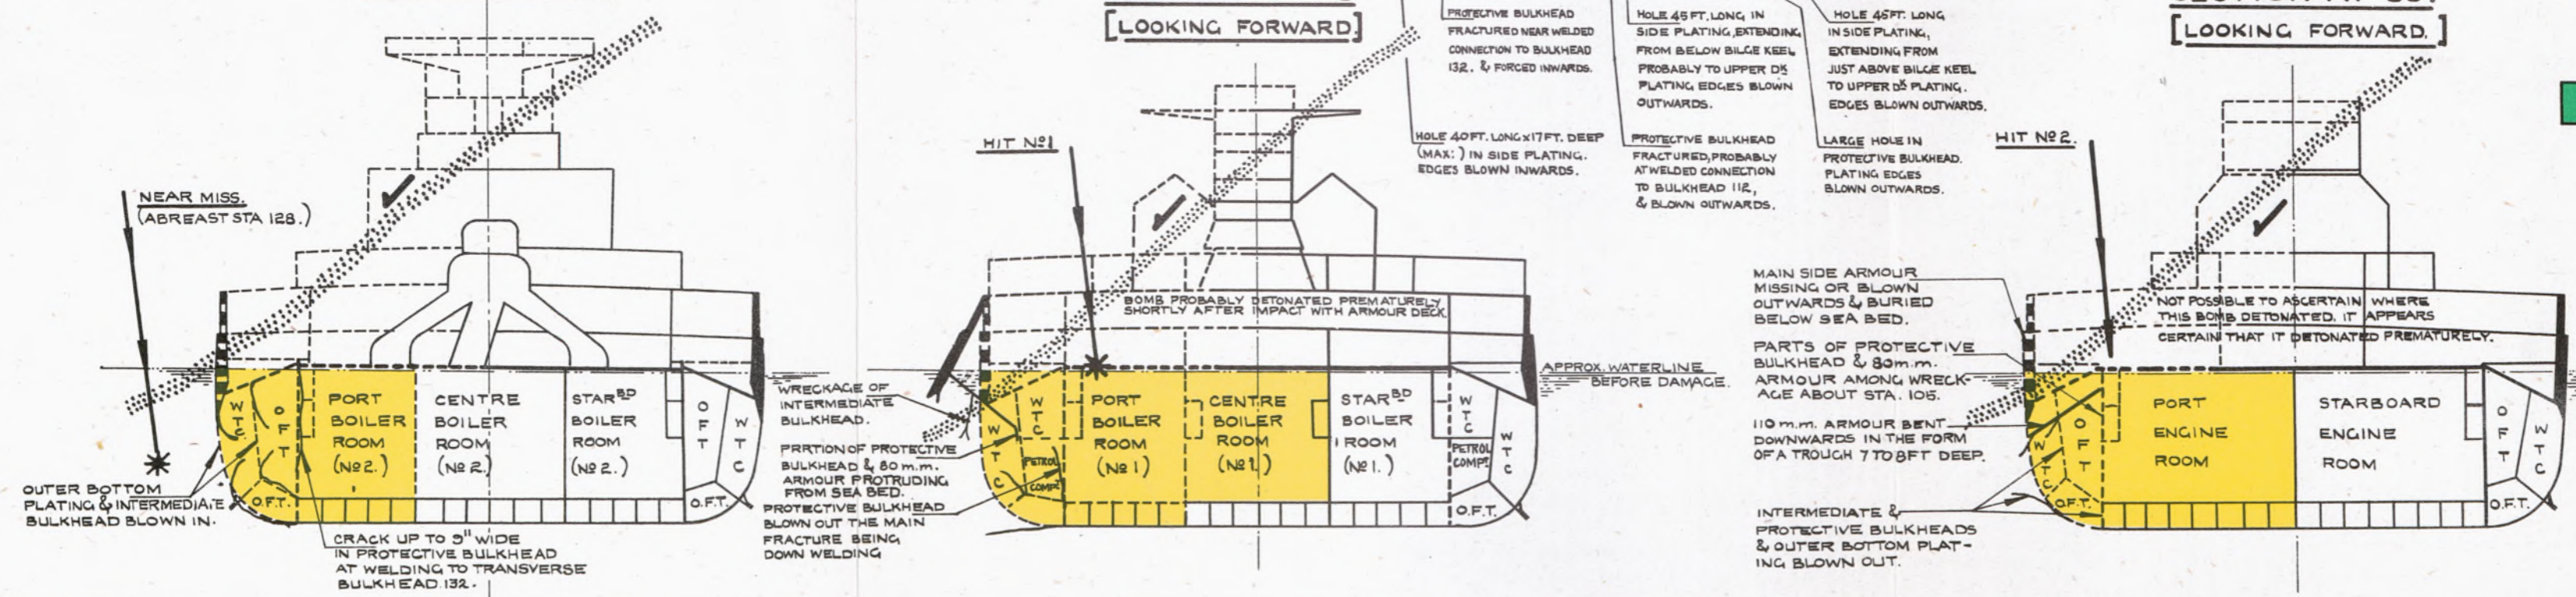
ADMIRALTY
D.N.C. DEPT.
NG/A 59
N.H.
FEBRUARY 1948.

NOTE -
THE EXACT PATHS OF THE BOMBS ARE NOT KNOWN. THE ARROWED LINES MERELY INDICATE APPROXIMATE POSITIONS IN WHICH THE HITS & NEAR MISSES OCCURRED.

PORTION OF SHIP ABOVE THIS LINE BURIED IN MUD, EXTENT OF STRUCTURAL DAMAGE NOT KNOWN.

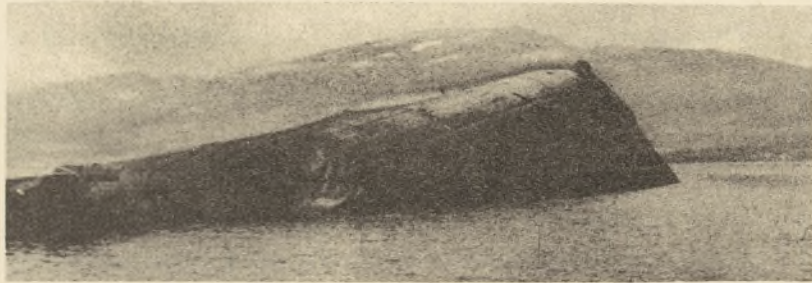
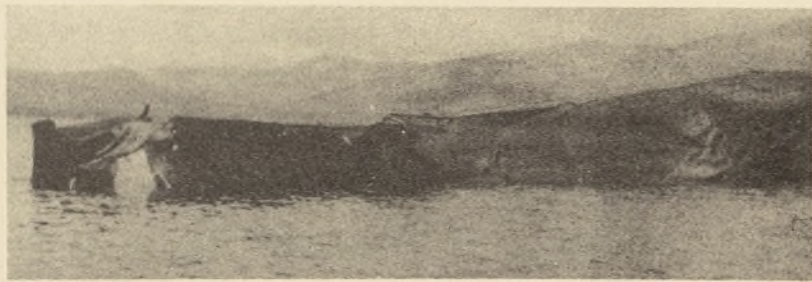
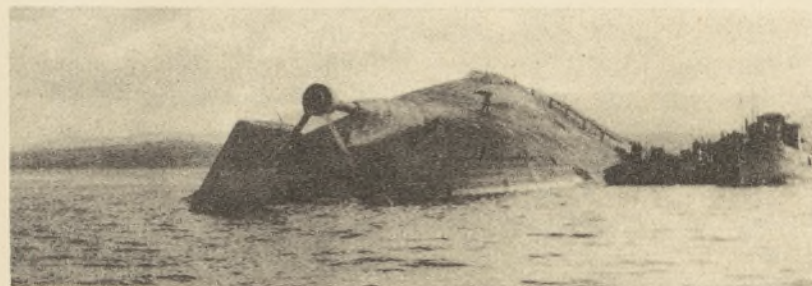
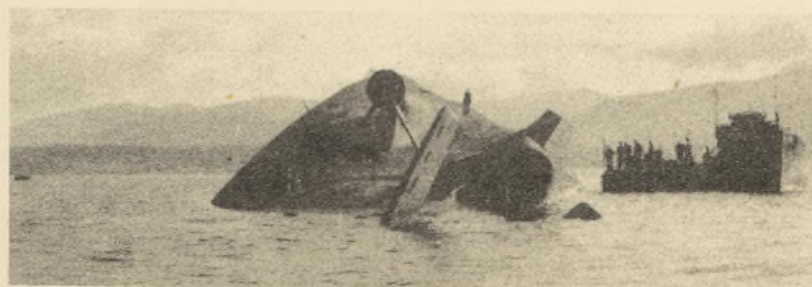
Plate B.1

General views of capsized ship.

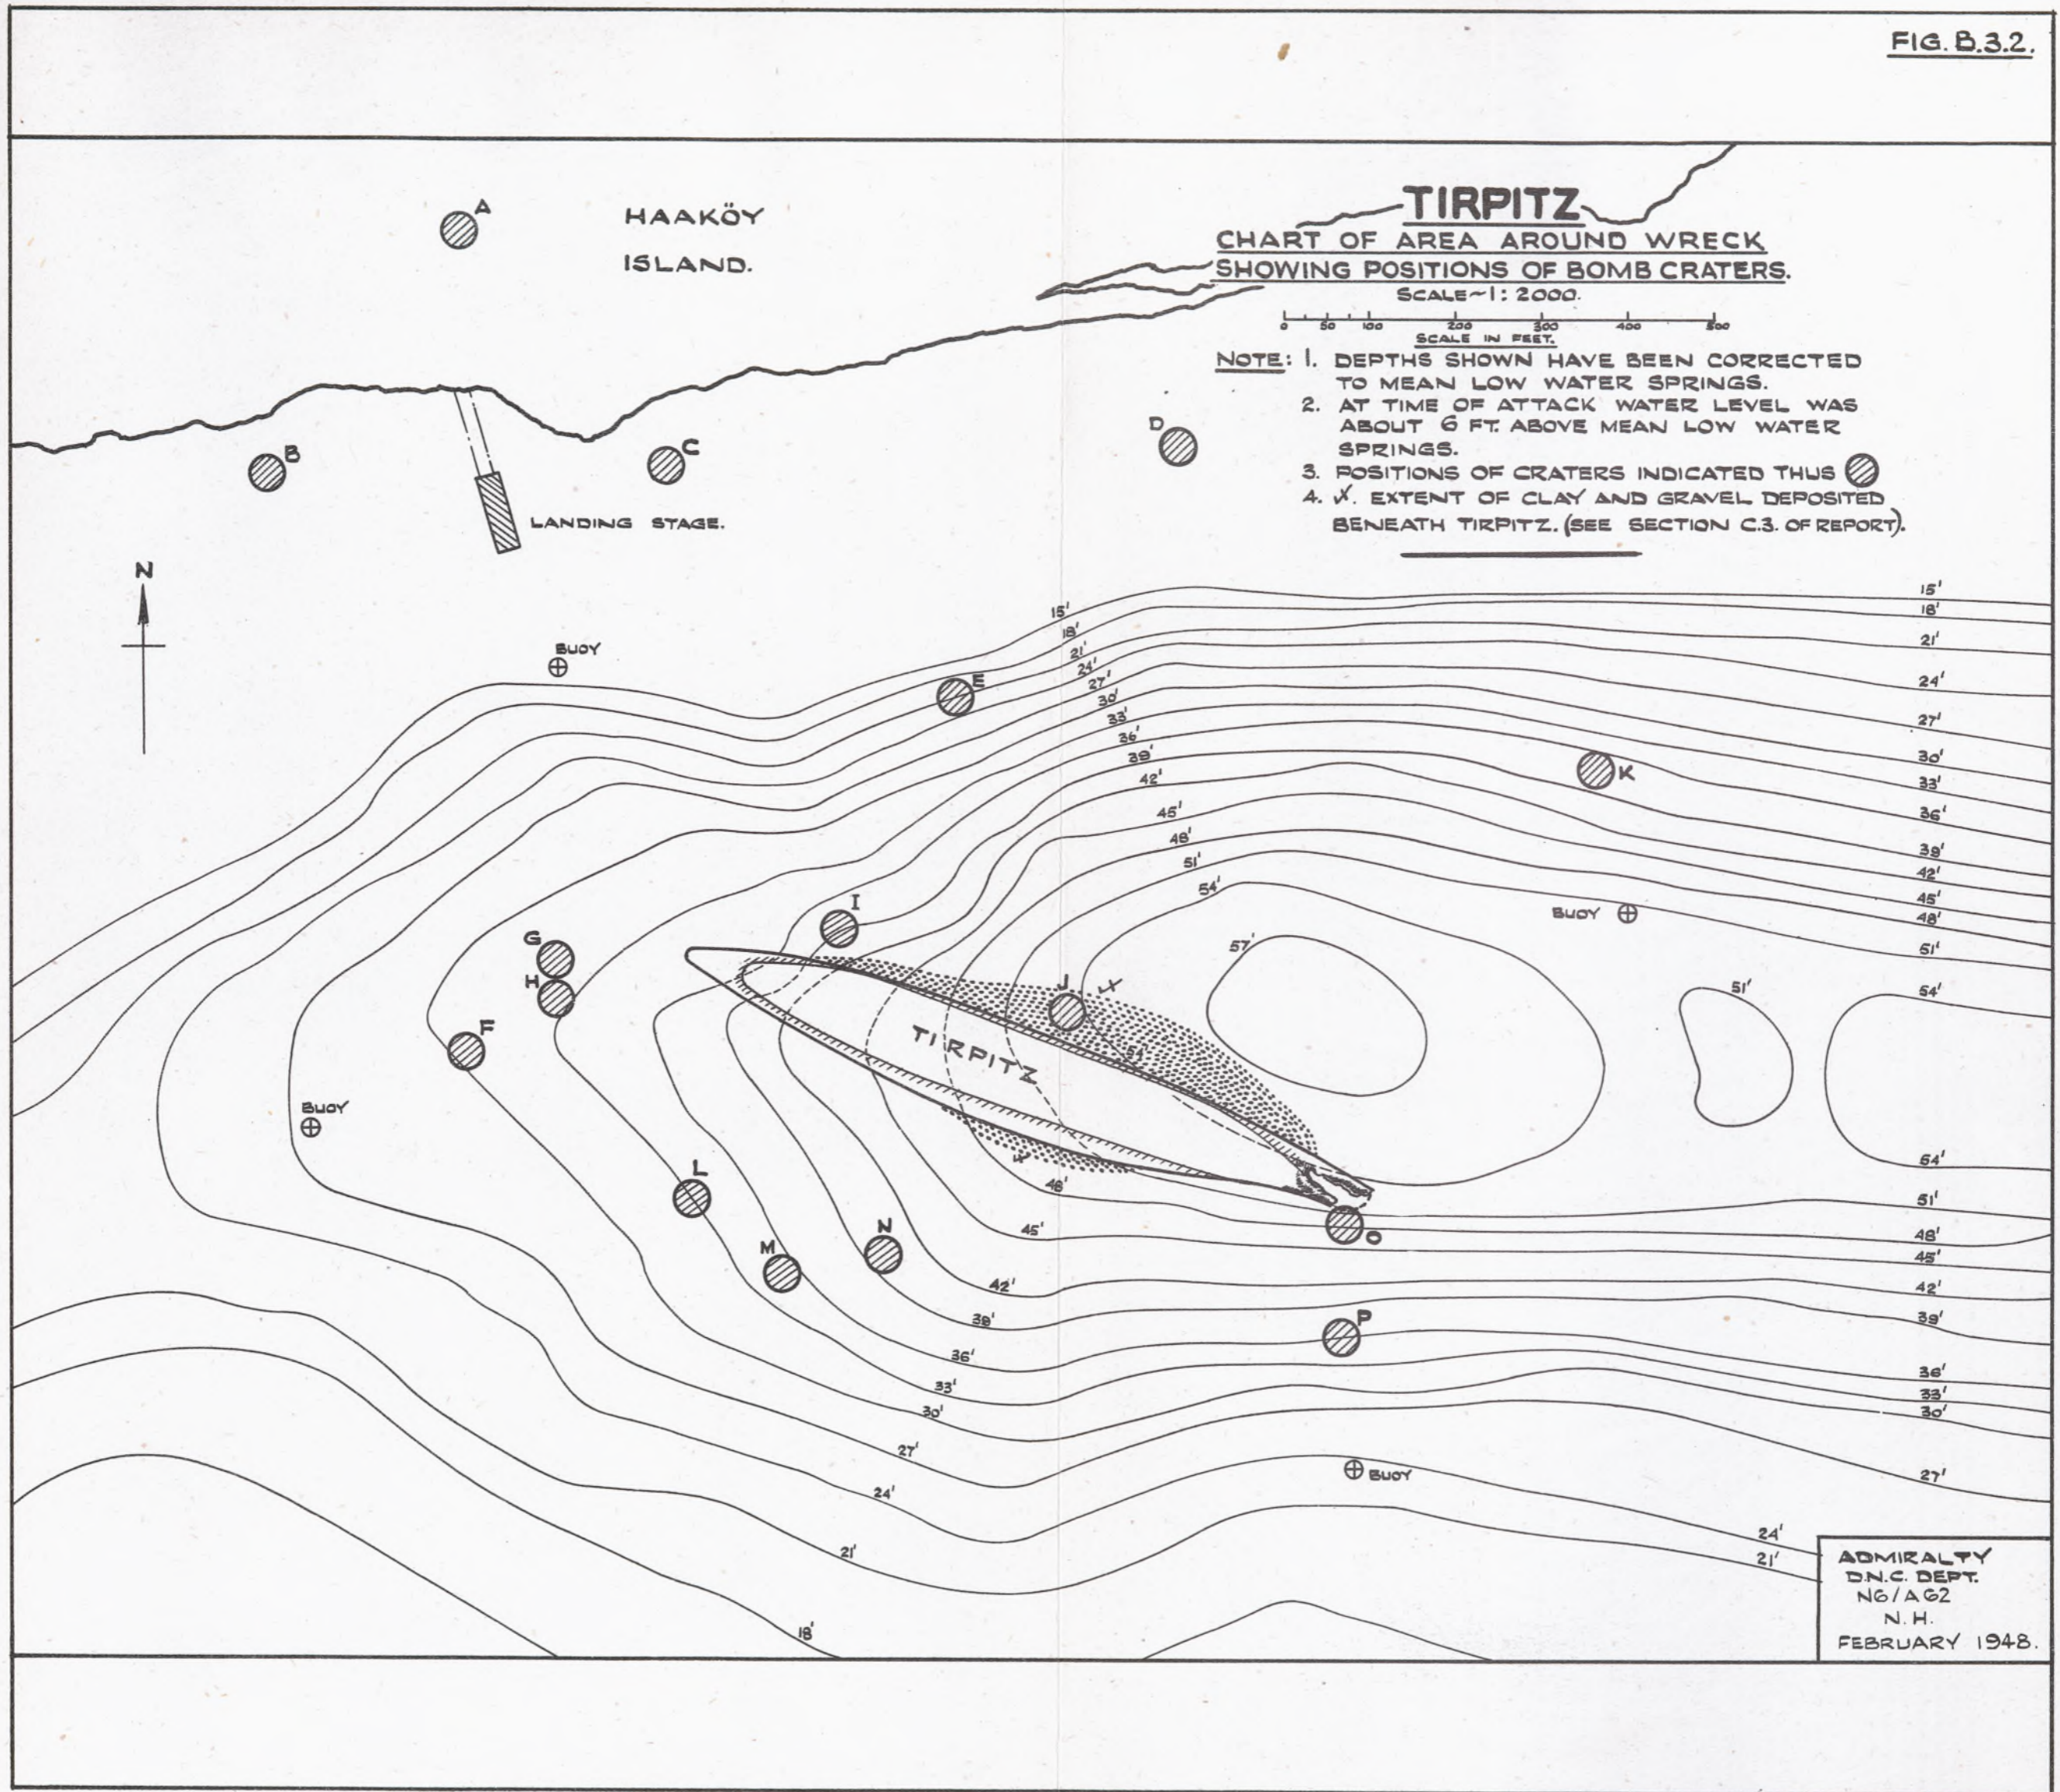
"TIRPITZ."

Damage due to internal explosion.

Crack in deck.
(See ① fig.B.4.2)

Bulkhead to
shell room
between C and
D turrets blown
out; crack down
line of welding.
(See ② fig.B.4.2.)

Shell room bulkhead fractured along line of vertical welding and blown in-board.

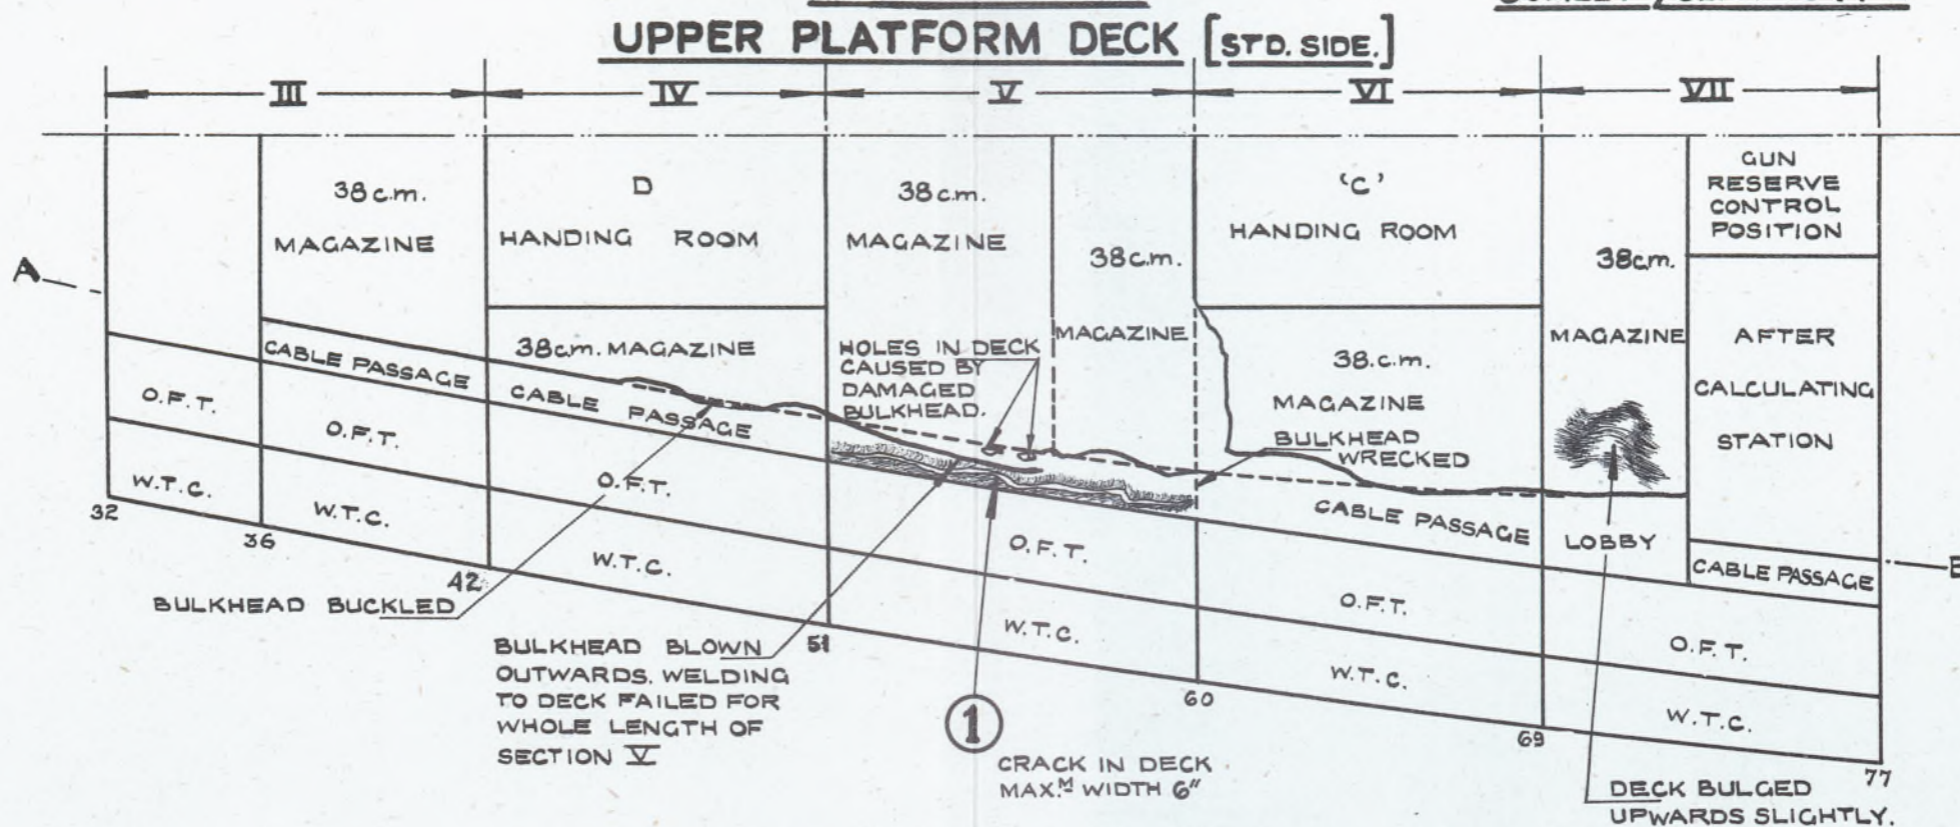
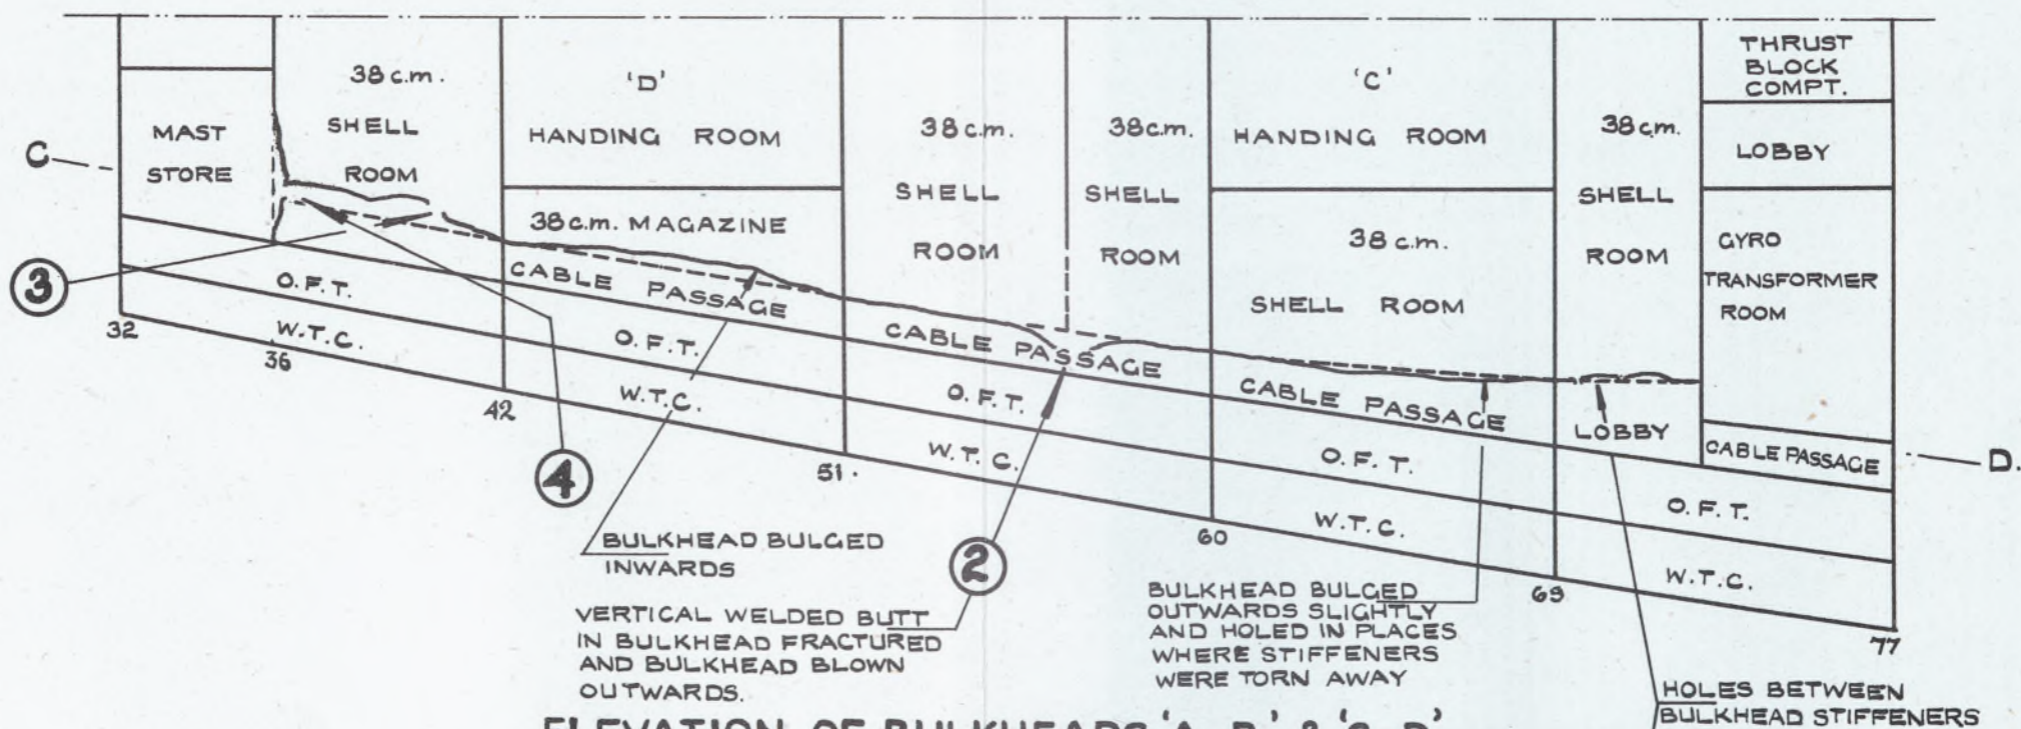
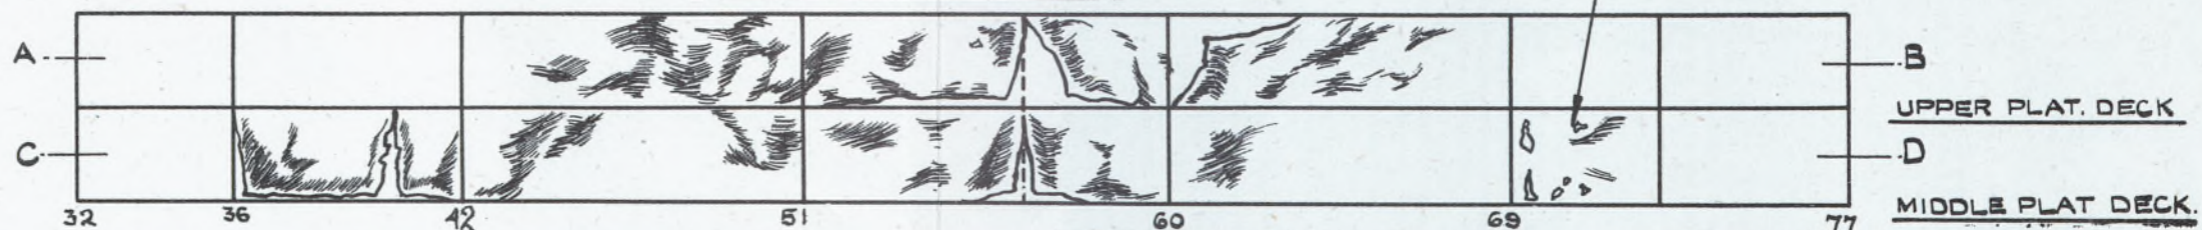
FIGURE
B.4.2.

2.1 It was found that considerable damage had been caused by an internal explosion in the vicinity of 'C' and 'D' magazines. The majority of this damage was underwater at the time of the survey, but it was possible at very low water to get access to the area through holes burnt for escape purposes and along the cable passages. Photographs on Plates B.4.2(a) and B.4.2(b) show details of the damage found and Figure B.4.2 shows the general extent.

2.2 The seat of the explosion was in the magazine between turrets 'C' and 'D'. On the starboard side of the ship the explosion damaged the inboard bulkhead of the cable passage and vented down the cable passage damaging decks and bulkheads as far aft as bulkhead 36 and as far forward as bulkhead 68.5. In both cable passages there were watertight doors at each transverse bulkhead. The hinges of all these doors in the area were broken and one of the doors was blown aft about 27 feet. The longitudinal bulkhead forming the starboard boundary of the shell room just forward of turret 'C' had a number of holes blown in it and gave the impression that a number of explosions had occurred in the shell room rather than one large explosion such as had occurred in the magazine. The products of the explosion had had sufficient force however to blow the watertight door in the main transverse bulkhead 68.8 on the lower platform deck a distance of 20 feet aft. Everything in this shell room had been blackened by the products of the explosion.

2.3 'C' gun-house when examined by divers was also found in a badly wrecked state. The starboard longitudinal protective bulkhead on the outboard side of the cable passages did not appear to be damaged.

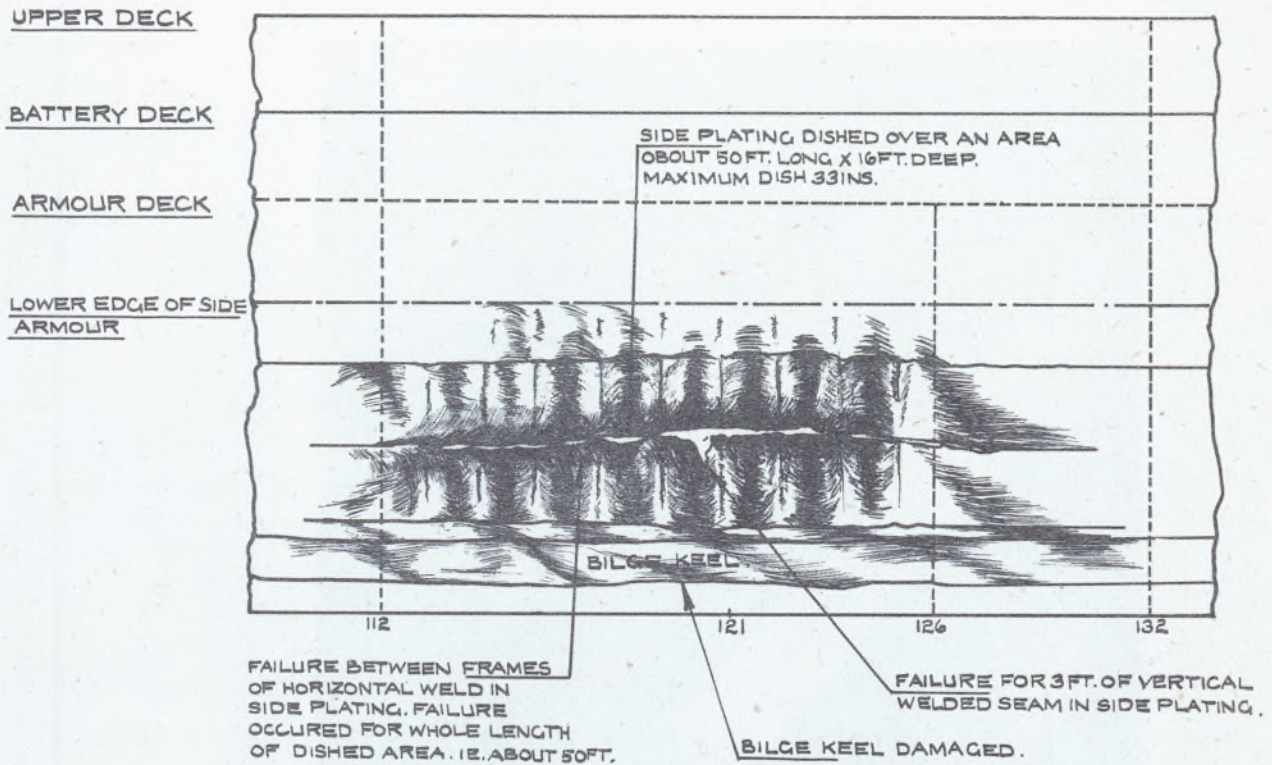
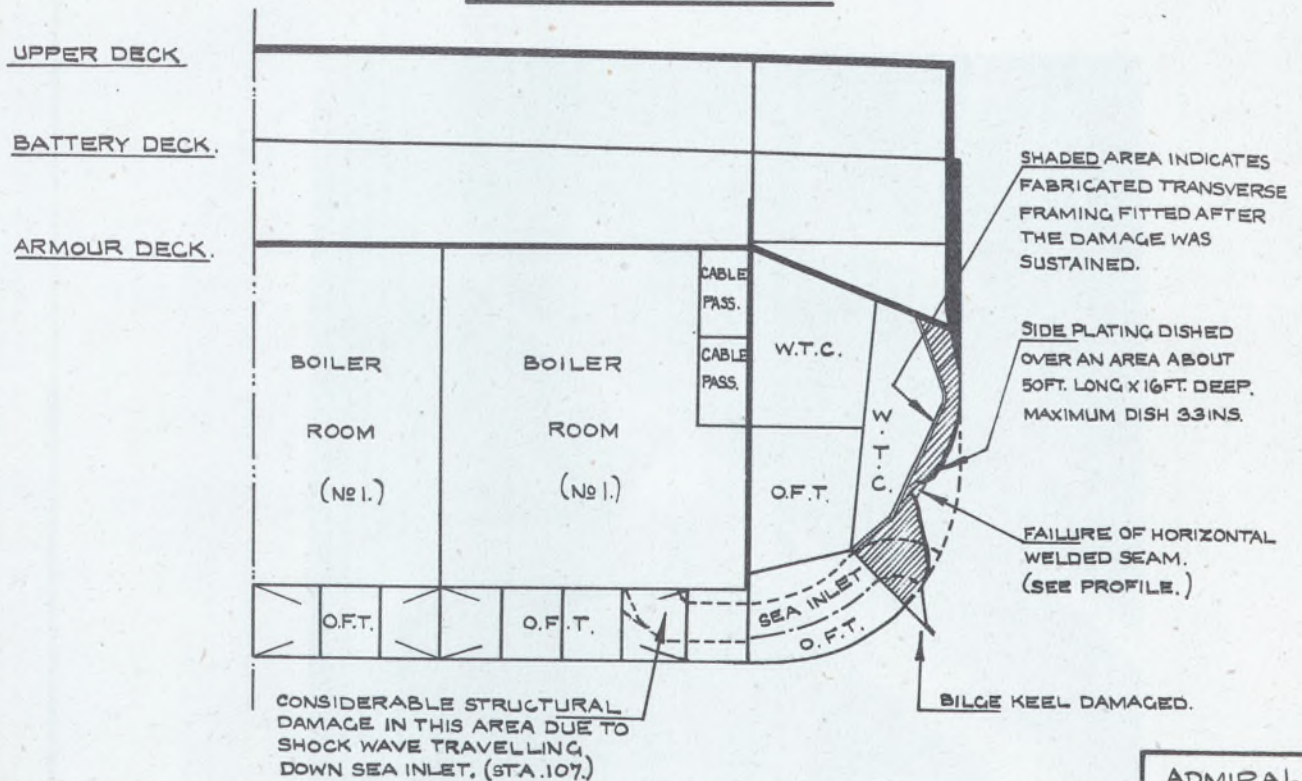
4.1 Figure B.4.4 shows damage caused by a near miss which detonated off the starboard side abreast the funnel. The dishing in the outer bottom plating extended over an area of 50 feet x 16 feet, the maximum inboard deflection at the centre being about 33 inches. Some authorities have wrongly supposed that this damage had been caused by a near miss with Tallboy. The bomb had caused splits in way of welding over a considerable area and these splits had been made watertight by driving in steel liners and welding on patches under water. The repair had been continued from inboard after pumping out the compartment.

Damage to plating and frames was extensive and the repairs must have taken many weeks (see Section 7 of Volume 2). No attempt had been made to alter the shape of the bulge in the bottom plating and fabricated transverse frames had been built around it. The pressure pulse from this near miss had caused considerable damage at the inboard end of the sea inlet which was close to the above-mentioned damage. As this was quite inaccessible no repair work had been carried out.
